Ministry of Infrastructure and the
Environment

Monitoring Traffic Safety

Longer and heavier vehicles

Datum July 2011
Status Final

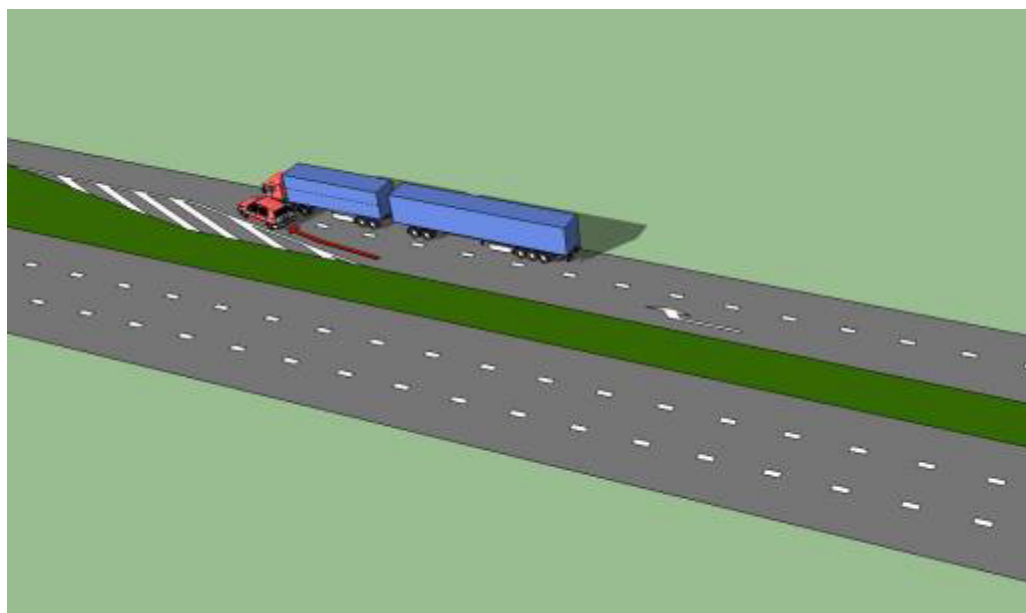
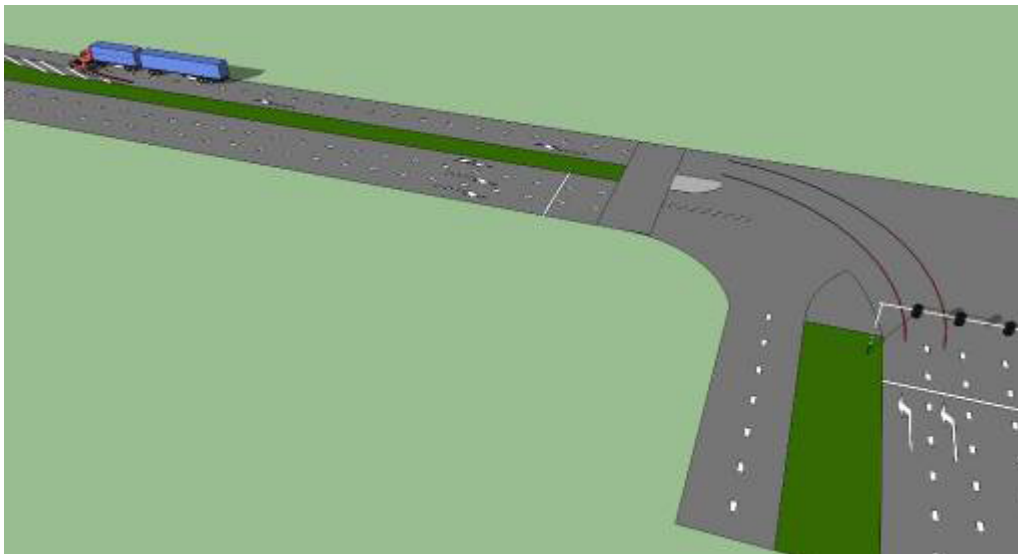
A passenger vehicle was driving in the outside lane with the intention to overtake the LHV driving in the inside lane. When the car changed lanes to merge across into the through lane in front of the LHV, the vehicles collided sideways, resulting in material damage only. The LHV was hit at the front left side. The passenger car failed to stop at the scene of the accident.

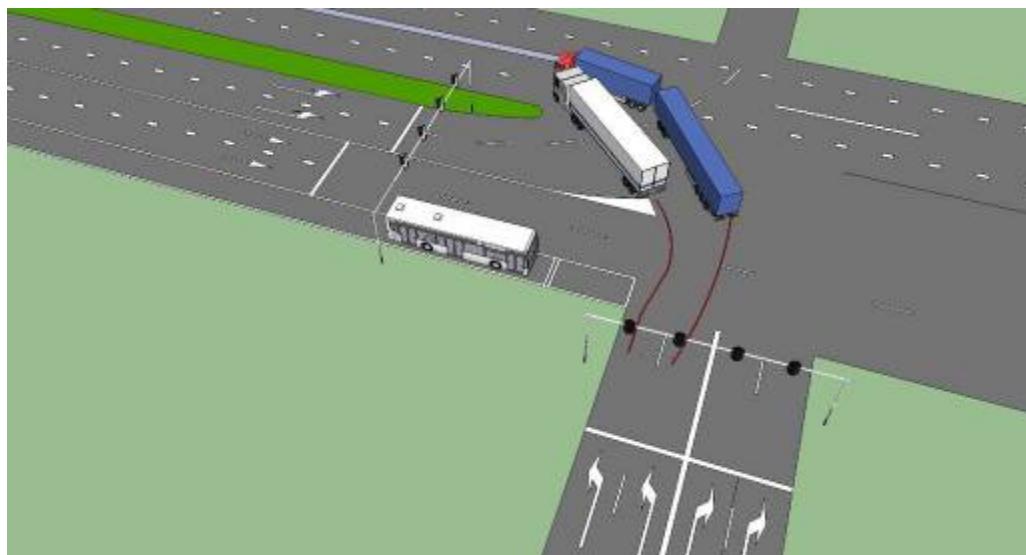
Adjacent to each other in the two left-turn lanes there was a regular truck on the outside lane and an LHV in the inside lane. As both approached the intersection, the regular truck negotiated the turn too widely, causing a side collision resulting in material damage only.

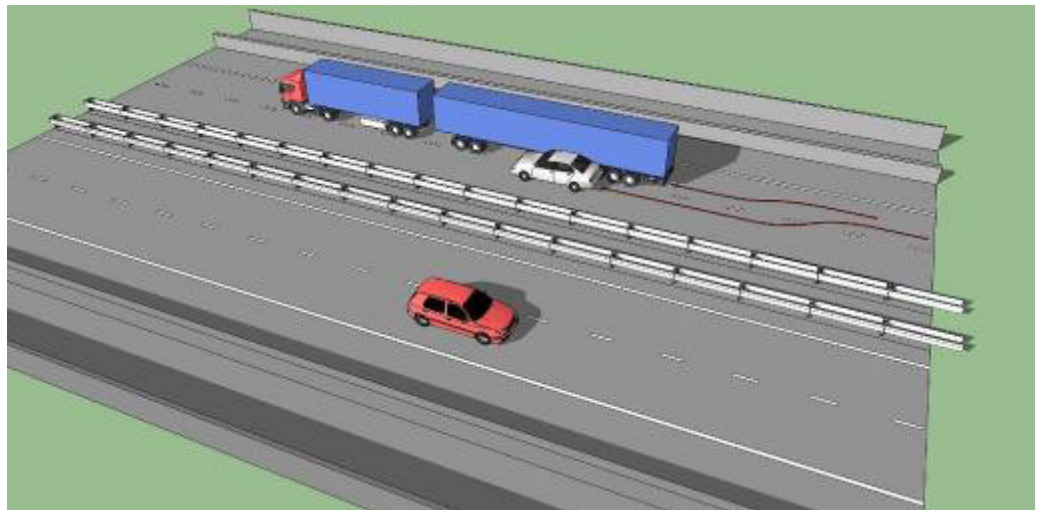
A passenger vehicle was in the process of overtaking an LHV combination when the LHV swerved. This led to a side collision resulting in material damage only.

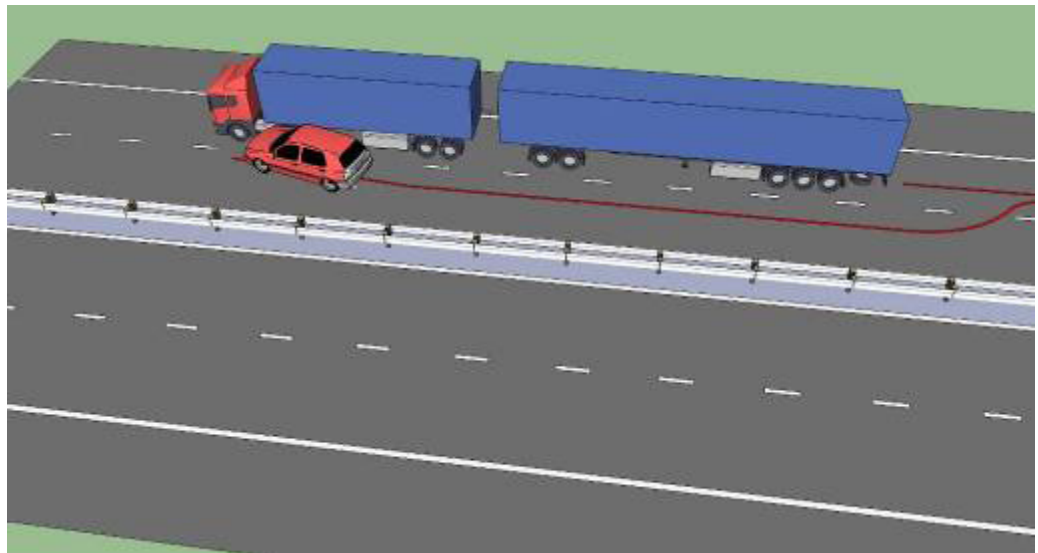
A passenger vehicle was in the process of overtaking the LHV, when the driver steered sideways too early, causing a side collision and resulting in material damage only. The LHV was hit on its left side. The driver of the passenger vehicle failed to stop at the scene of the accident.

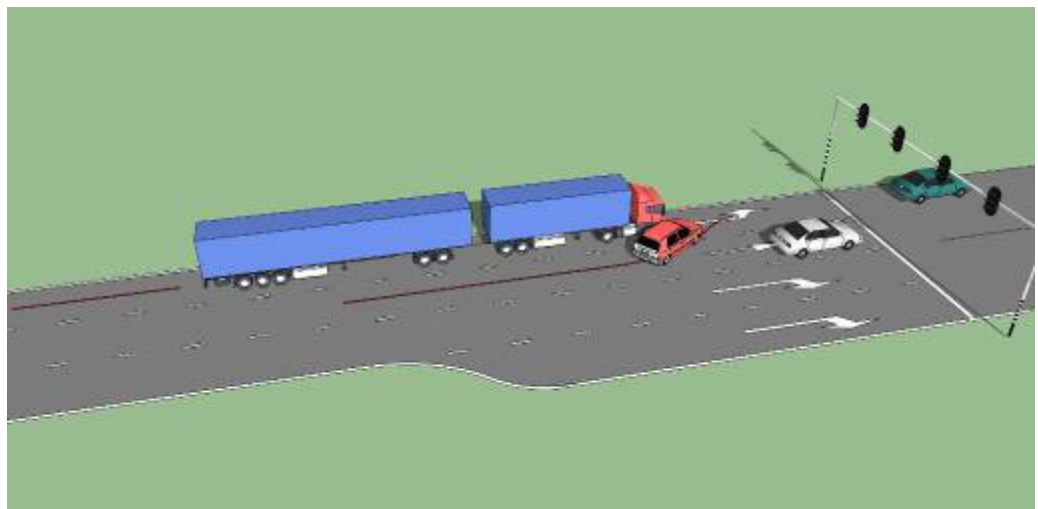
The LHV involved had pulled up in the lane designated for traffic turning left for the A10 northbound. The passenger vehicle involved had pulled up in the through lane. The traffic lights for both these lanes changed to green simultaneously. As traffic started moving, both the LHV and the passenger vehicle accelerated. At that point the driver of the passenger vehicle decided he wanted to turn left for the A10 northbound and changed lanes right in front of the LHV. The space to do so had become available as the car in front of the LHV had accelerated more swiftly than the LHV. Although the driver of the passenger vehicle presumed that the driver of the LHV had noticed him, he was in fact positioned in the LHV's blind spot. This led to a side collision resulting in material damage only.

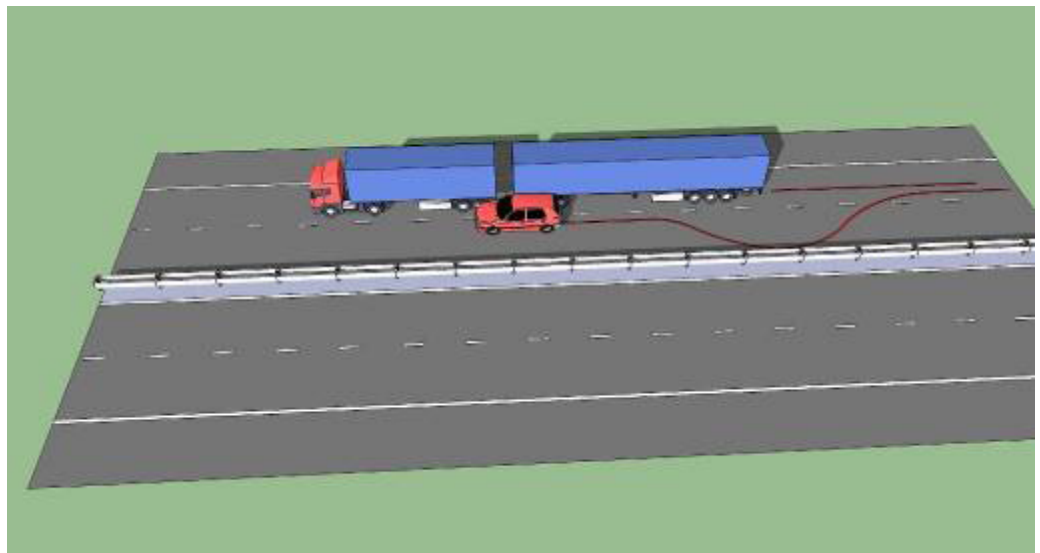
A passenger vehicle was driving in the outside lane, adjacent to an LHV driving in the inside lane. According to the police accident record, the car presumably drifted into the grassed central reserve, upon which the driver of the vehicle oversteered in the opposite direction, leading to a rear-end collision resulting in material damage only. The passenger vehicle thereby hit the LHV between its trailer and dolly.

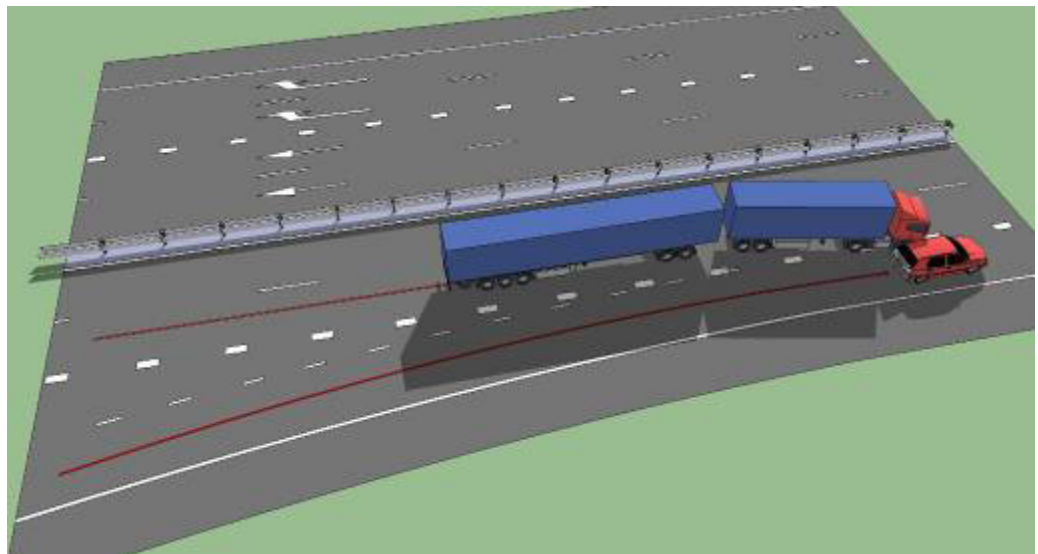
The passenger vehicle was coming from the A50 and driving on the inside lane. The LHV came from the A28 from the direction of Amersfoort and switched to the right lane to continue on the weaving lane towards the exit, Zwolle south. The LHV driver failed to see the passenger vehicle driving on his right because it was driving in the LHV's blind spot. This caused a collision with material damage only.

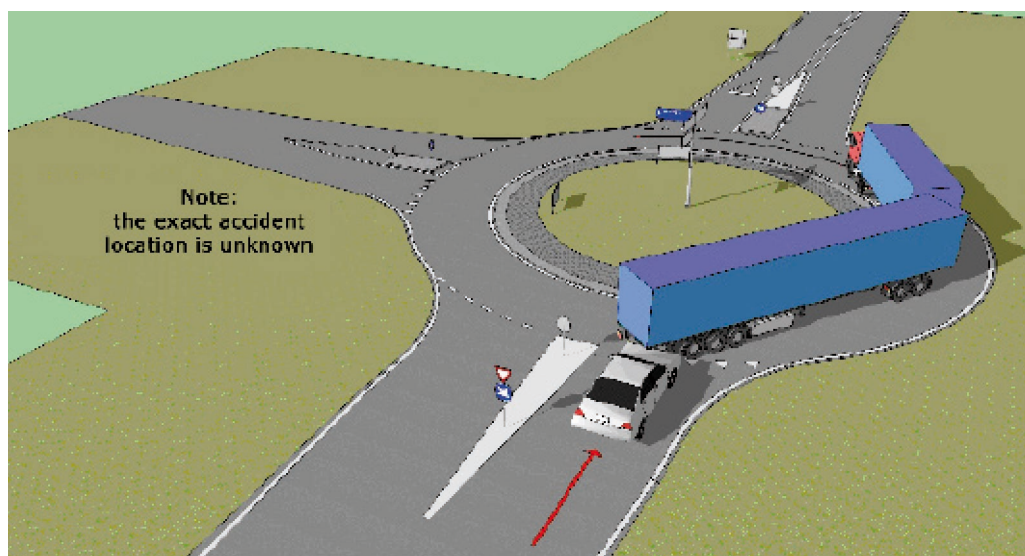
The LHV approached the roundabout and as it did, felt a knock. The driver declared to the police that he wasn't aware he had been hit, and had continued on his way. He later noticed damage to his trailer which had clearly been caused by another vehicle. According to the accident record, there was material damage only; the damage corresponded with a side collision with another – passenger – vehicle.

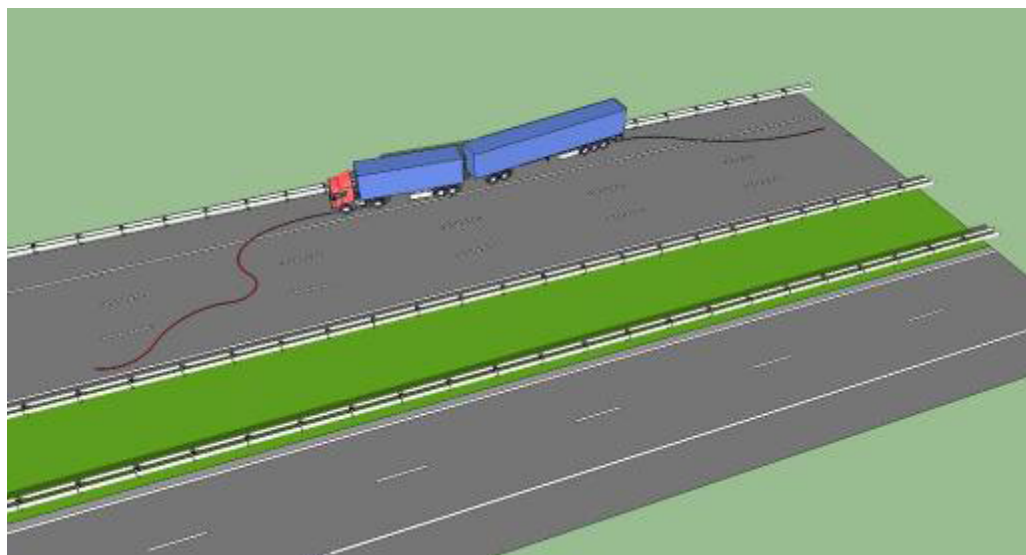
The driver of the LHV lost control of his vehicle. This led to the trailer hitting the guard rail, causing the LHV to skid and the trailer to overturn. This single-vehicle accident resulted in material damage only.

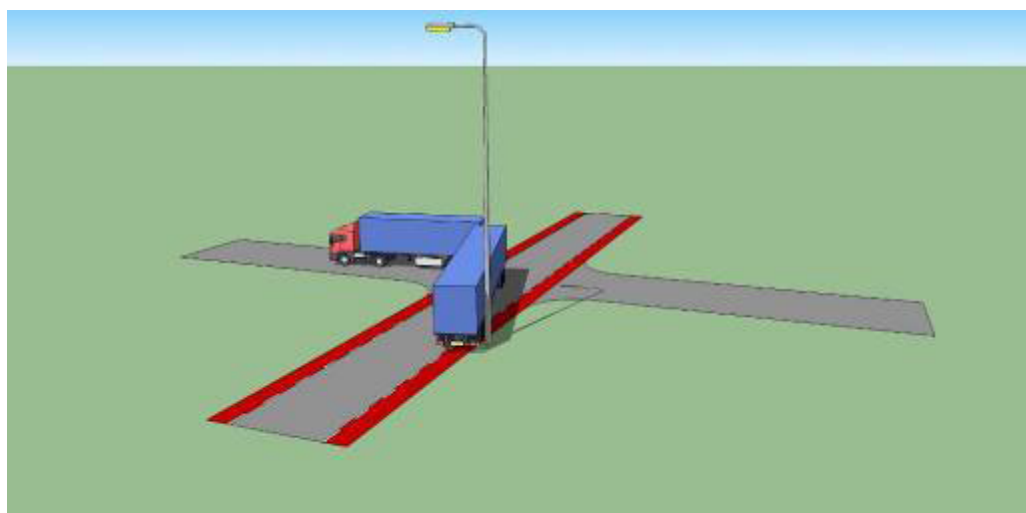
As the LHV made a left turn at the intersection, the far corner of its trailer swerved out into a lamp post. This collision resulted in material damage only.

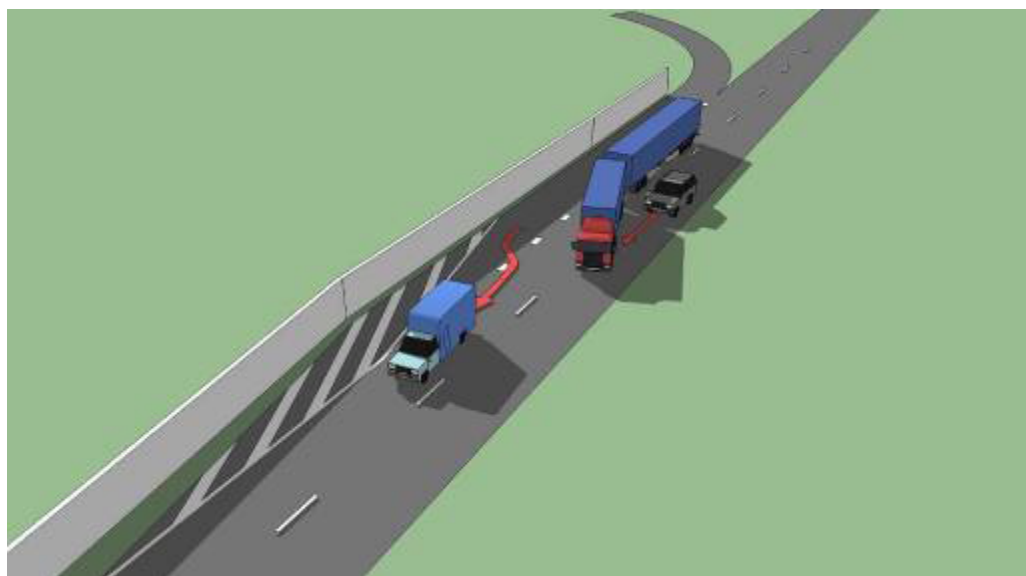
To give merging traffic sufficient space the LHV, which was travelling on the inside lane on the A17, changed to the outside lane. The driver of the LHV failed to notice a delivery van on the outside lane. This resulted in a side collision whereby the delivery van was badly damaged. The accident resulted in material damage only.

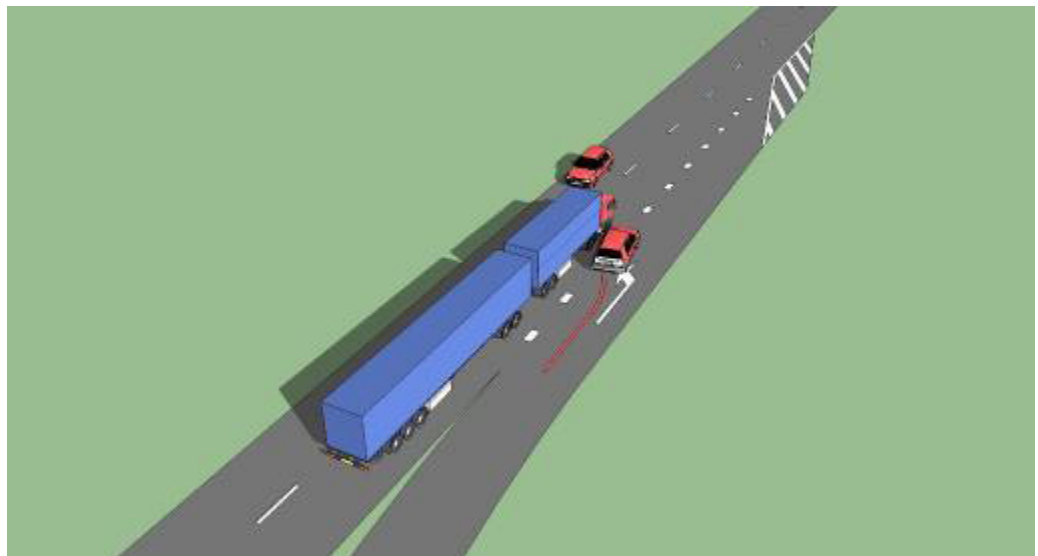
While merging on the N36, a passenger vehicle collides with the right side of an LHV. The accident resulted in material damage only. The accident report does not contain any further details on the circumstances.

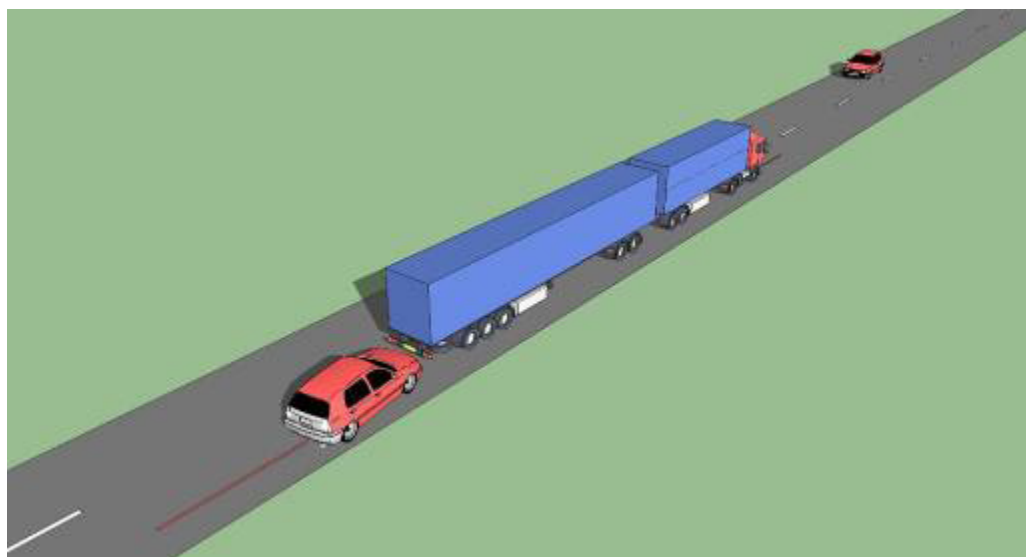
While the LHV was travelling on the N369, two children of eight and nine years of age threw chestnuts at the side of the cabin. This shocked the LHV driver and caused him to slam on the brakes, because of seeing children playing on the roadside. The passenger vehicle travelling behind the LHV subsequently collided with the LHV; this in spite of the fact that the passenger vehicle was travelling at a safe distance from the LHV. Both vehicles were driving around 70 kph, and there was no reason why the passenger vehicle would have expected the LHV to suddenly brake. After the collision the driver of the passenger vehicle suffered injuries to her neck and shoulder. After being checked by ambulance staff on site, she was allowed to go home.

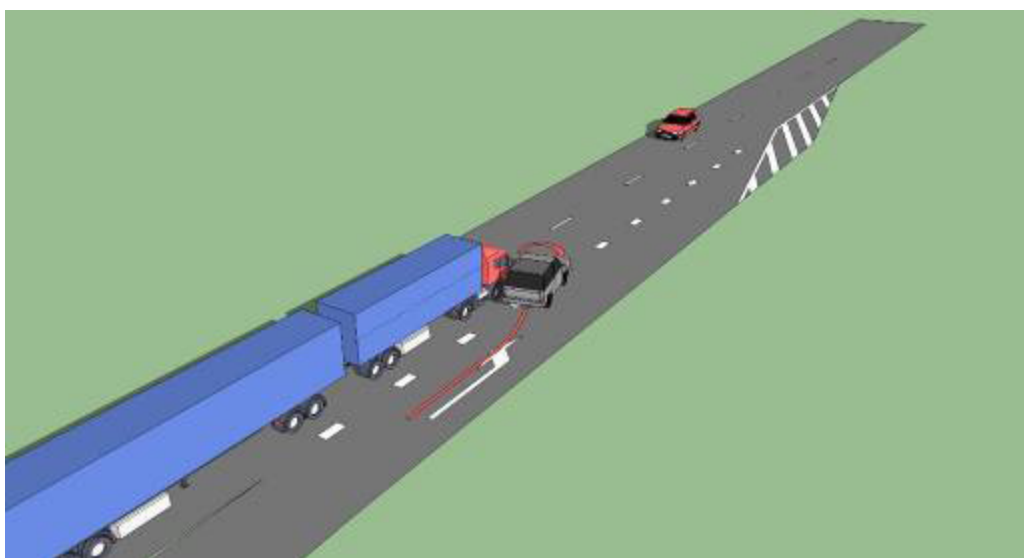
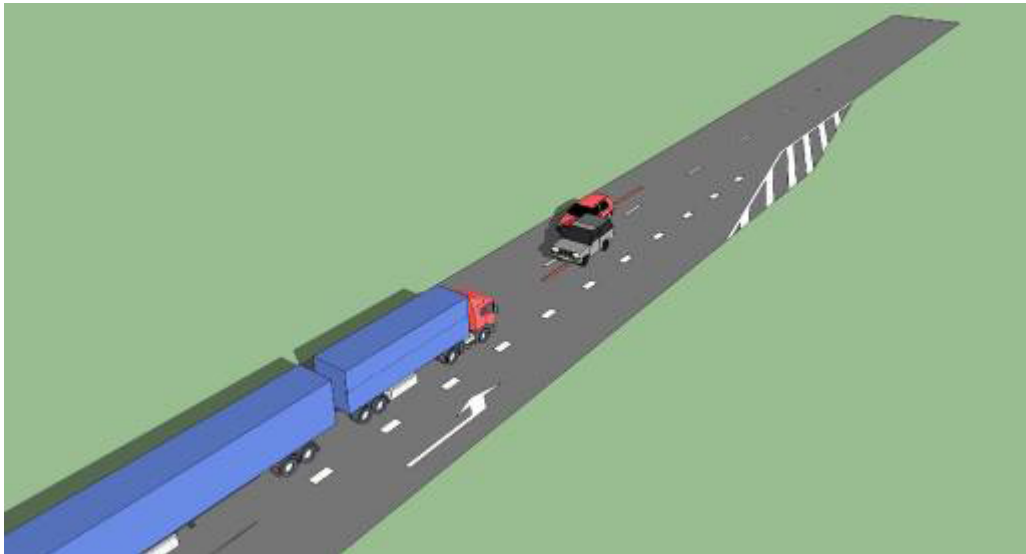
While attempting to merge on the N50 a delivery hit an LHV, already travelling on the N50, on its right front side. The delivery van turned on its axis and collided with the LHV once again; this time both vehicles hit each other's front. The delivery van, which was now facing in the opposite direction on the N50, reversed and hit an oncoming passenger vehicle from the other direction. The accident resulted in material damage only.

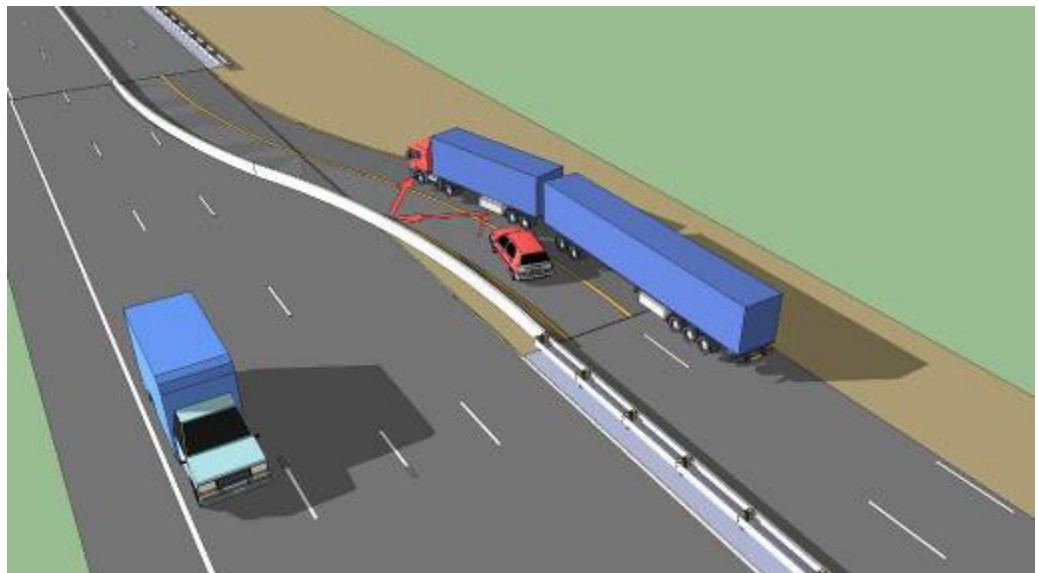
Comment: there were roadworks at the time of the accident. A top speed of 90 kph applied at the time. In view of the fact that this road section is normally a straight road, it is highly likely that the narrow lanes and curve in the road meant there was less room for both vehicles to make sideways movements. The accident resulted in material damage only.
