**Project n°AST3-CT-2003-502907**

**Project acronym AISHA  
Aircraft Integrated Structural Health Assessment**

**Publishable Final Report**

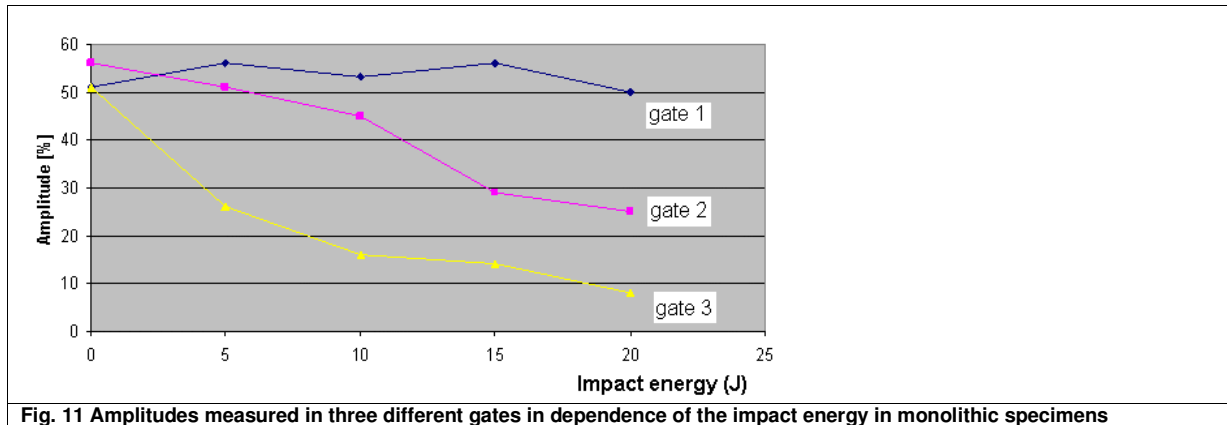
Fig. 11 Amplitudes measured in three different gates in dependence of the impact energy in monolithic specimens

For monolithic specimens (Fig. 11), there is correlation between signal amplitude and damage in the second and third identified wave package.

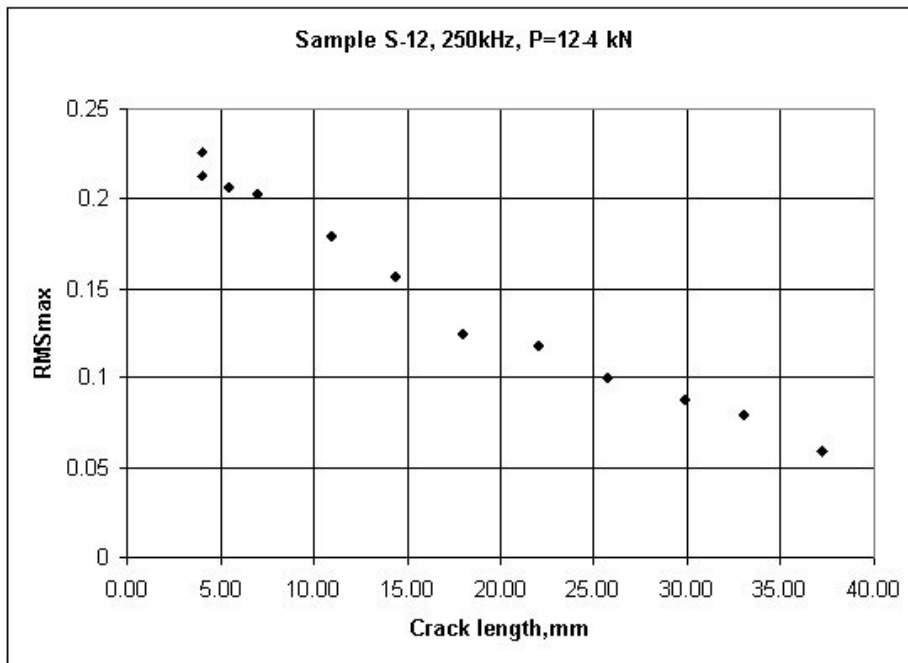
Fig. 13 Example of signal/damage correlation

During the next stage, the loading was periodically interrupted for the Lamb's waves detection with the half length of crack approximately 2.5, 5.0, 7.5, 10.5, ... mm. This allowed to obtain reliable correlations between signal and damage (length of crack)".

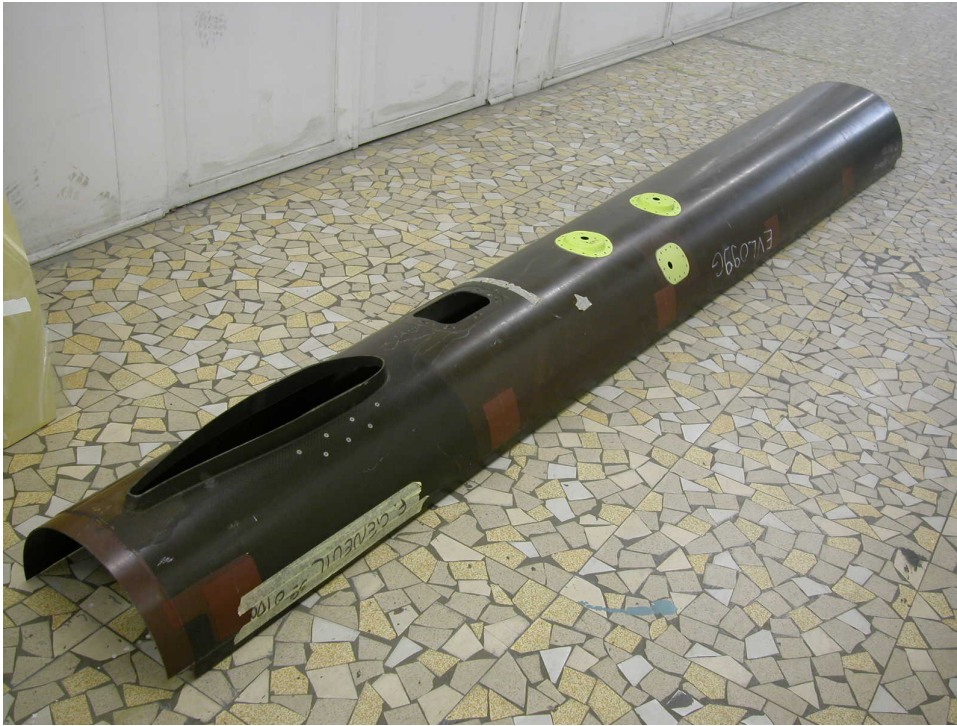
**Fig. 20 Photographs of the demonstrator**

In this work package, the achievements from the laboratory tests on small samples are transferred to a real large scale component. A tail boom demonstrator of the EC 135 was selected for the full-scale test by Eurocopter France. It is a specimen with complex setup and various discontinuities like inserts, holes and both artificial and impact-induced defects.

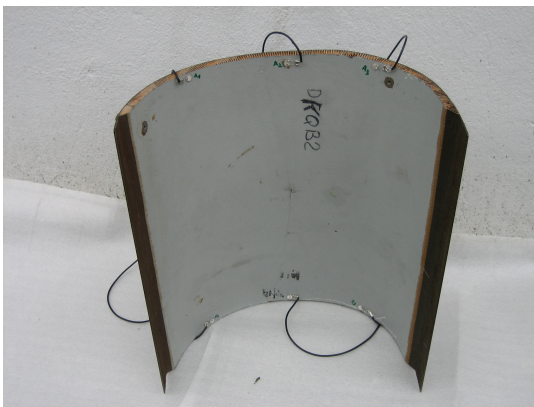
**Fig. 21 Cut-out of EC135 tail boom**

First laboratory evaluations on a cut-out allowed optimizations on piezo type and positions as well as electrical excitation (Fig. 21). It could be demonstrated, that Lamb-waves in a frequency range from 8 to 18 kHz penetrate the whole sandwich (skins as well as the core). Consecutively, impact damages and holes were put into the specimen. The component's dimension is large enough compared to the typical wave length. Therefore we have no disturbing reflections and could achieve good damage detection capability, especially at 8 kHz. Both artificial holes and impact damages result in a significant increase of time-of-flight in that sound path and, even more significantly, a decrease of amplitude.

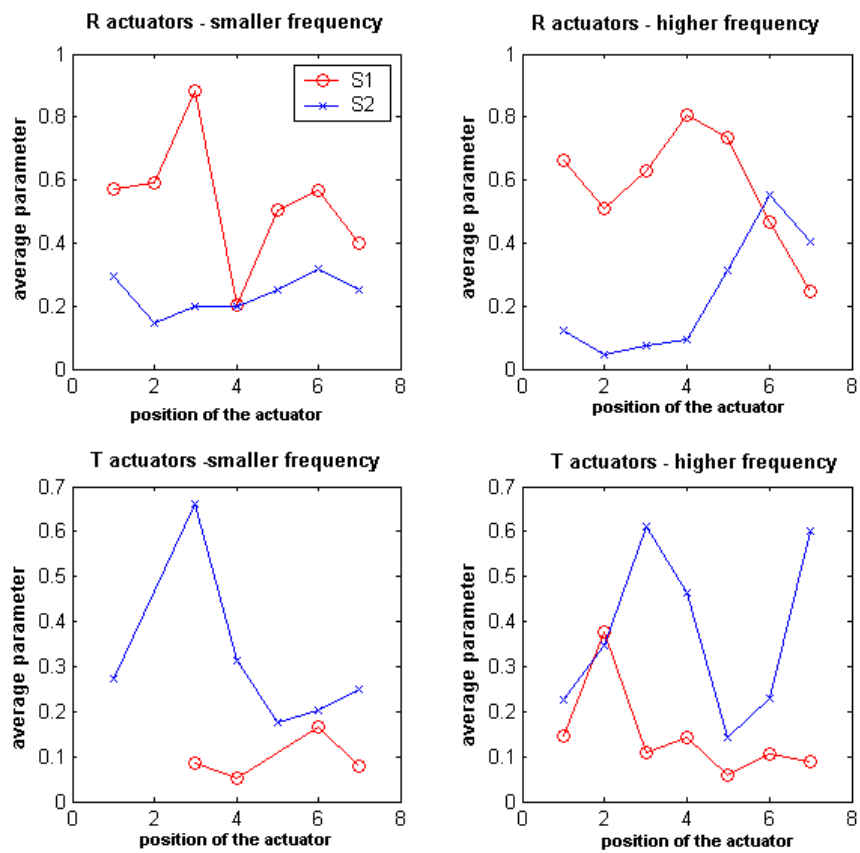
Fig. 25 The 8 different parameters calculated were averaged after all of them were scaled to the [0,1] interval, for the 4 different measurements using the R and T actuators with smaller and higher frequency ranges. On each graph circles (crosses) note the measurements obtained with S1 (S2) optical fibres

Signal processing methods based on comparing the time-frequency images of signals obtained before and after the impact are used for detecting damage in composite materials. The method was tested on data obtained in a large-scale experiment made on a helicopter tail, using of real impacts and a small-scale experiment of using pseudo-defects. The results show that in spite of big fluctuations a global view of all 7 parameters calculated and averaged can show, with a very good approximation, the position of the damage (Fig. 25).

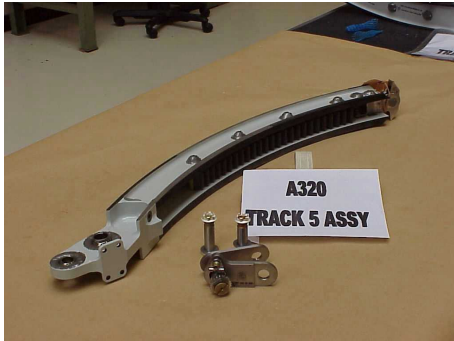
Fig. 27 Slat track for AIRBUS A320

Lamb waves are inappropriate to detect damages in slat tracks due to the mismatch between the size of the slat track, the corresponding wavelength and the size of the defect. The application of Rayleighwaves providing a smaller wavelength was proven to be an alternative, but it appeared that the use of classical wedge sensors is inappropriate due to restrictions of the slat-track when it is in function (see picture of the mounted slat-track).

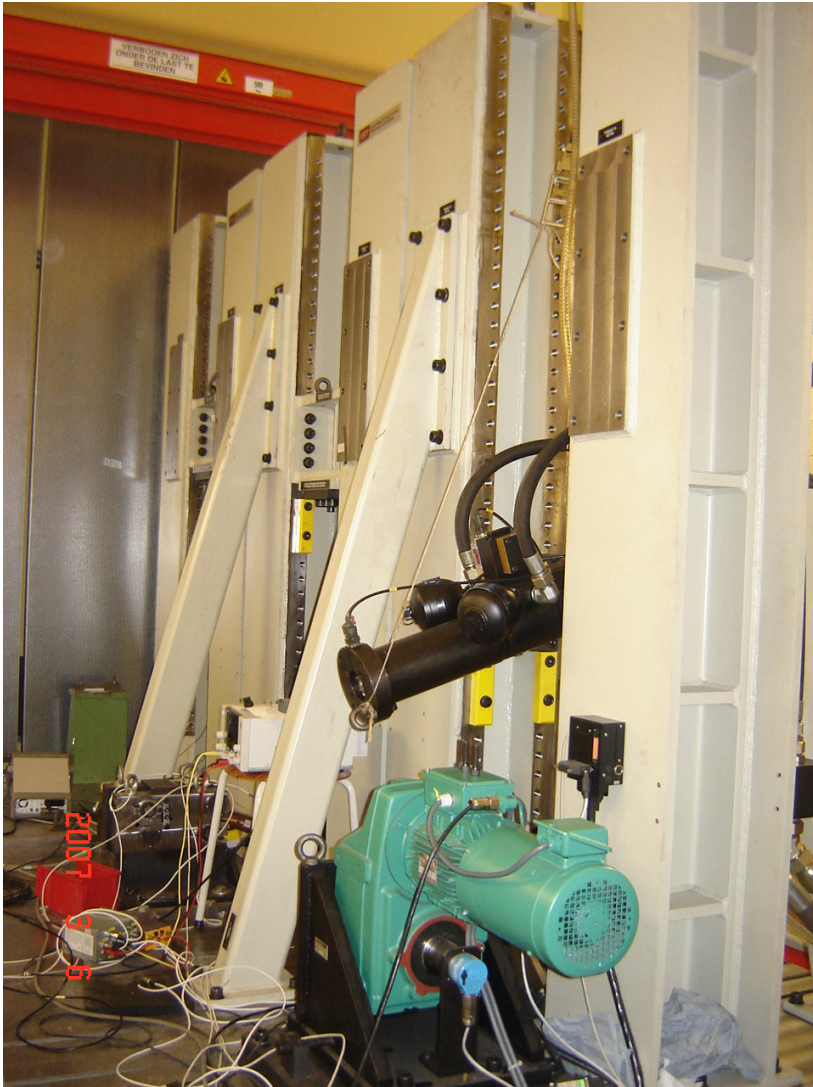
Fig. 32 Test rig of ASCO at the VUB (Free University of Brussels). In the foreground, a bi-axial test rig can be seen.

The test was performed using an uni-axial test rig and here, and the sensor connection was ensured during the whole process, such as proven by measurements of the electric impedance of the sensors. Also in this case, the growth of the crack was visible by a strong response of the ultrasonic signal. The tests are still in progress and therefore, not all results are available at the moment. A particular feature of this measurement is that the cracks are only open if the slat track is under load. This corresponds to operational conditions, where potential cracks would only be open during the start and landing of the aircraft. Therefore, ultrasonic measurements were performed under load and without load to get information on both cases.
