Quality Control and Monitoring of electrically isolated post- tensioning tendons in bridges

**ETH Zurich, Institute of Building Materials, Zurich
Prof. Dr. Bernhard Elsener**

**Forschungsauftrag AGB 2004/010 auf Antrag der Arbeitsgruppe
Brückenforschung (AGB)**

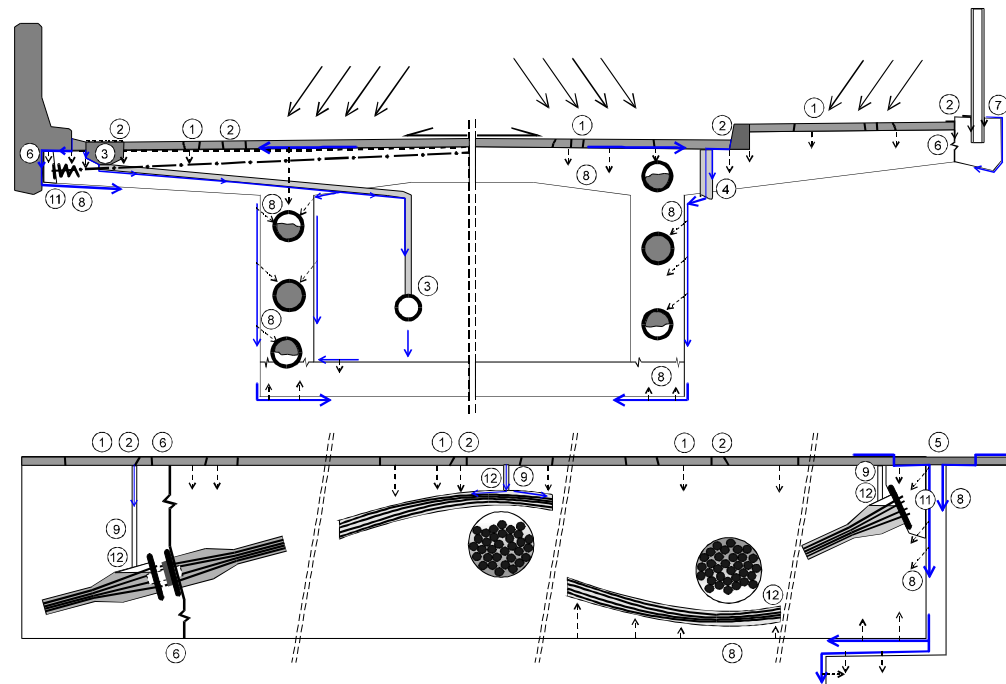
Figure 1: Hazard scenarios for pre-stressing steel in a typical box girder bridge. Indication of potentially "weak points" where water (possibly contaminated with chlorides) can gain access to the tendons and cause corrosion. 1: Defective pavement (e.g. cracks), 2: Missing or defective waterproofing membrane incl. edge areas, 3: Defective drainage intakes and pipes, 4: Wrongly placed outlets for the drainage of wearing course and waterproofing, 5: Leaking expansion joint, 6: Cracked and leaking construction or element joint, 7: Inserts (e.g. for electricity) [6]

Tendons contribute decisively to the serviceability, safety and durability of prestressed concrete bridges. Optimum corrosion protection of post-tensioning tendons has been a priority since the beginning of this technology [1]. The UK temporary ban of grouted post-tensioning tendons, from 1992 to 1996, has initiated a review of all aspects related to durability of post-tensioning tendons [2]. Traditionally, ducts for bonded post-tensioning tendons have been made from steel stripes with a special corrugation. A long experience and generally good „track record“ with these tendons is available from many different applications. Their overwhelming use has allowed the creation of national and international standards. Despite a generally good long-term behaviour, some corrosion problems are documented that rose concern about the durability of post-tensioning tendons. An overview on corrosion damages of pre-stressing steel in Germany has been published [3], the situation in North America, Europe and Japan is summarized in papers presented at the fib/IABSE workshops „Durability of post-tensioning tendons“ in 2001 [4] and 2004 [5]. Recently, the situation in Switzerland was analyzed [6]. From 143 structures approximately half showed small to significant corrosion damage of the pre-stressing steel. From 27 sufficiently documented bridge case studies, 12 bridges were dismantled of which 9 for traffic reasons and only 3 due to lack of serviceability, structural safety and durability. In this group of dismantled bridges (where a much better tendon inspection is possible) significant damage with corrosion of the pre-stressing steel was found in 2 bridges. The reason was chloride-containing water penetrating at „weak points“ such as expansion joints, drainage systems etc. to the steel duct [6]. A typical scenario of deterioration of a prestressed box girder is shown in figure 1.

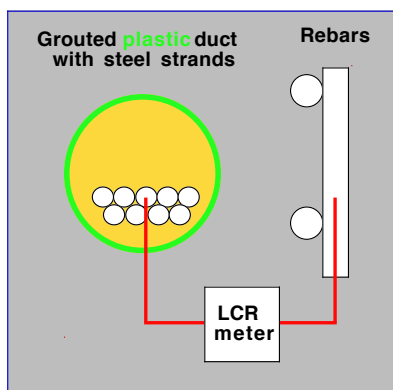
The impedance measurements are performed between the steel strands in the grouted ducts and the normal reinforcement in concrete (figure 2a). The measuring system thus includes the grout in the duct, the duct (with pores and defects) and the concrete surrounding the duct. Grout and concrete are (at least in the range of measuring frequencies between 100 and 1000 Hz) pure resistances, whereas the polymer duct is essentially a capacitance in parallel with a very high resistance (figure 2b). Any system related imperfection (e.g. not fully closed grout vents) and/or defect in the duct is represented by an ohmic resistance in parallel.

Fig. 2a: Principle of measuring the electrical impedance of a tendon with the LCR meter

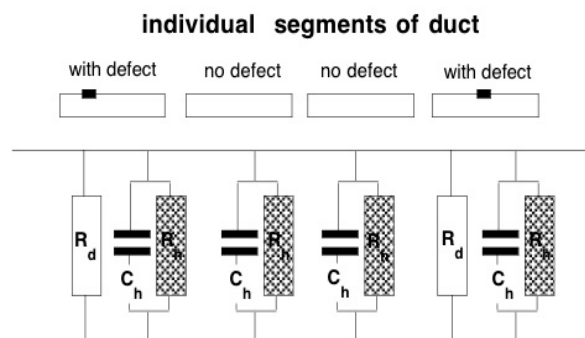
Fig. 2b: Electrical equivalent circuit for an electrically isolated tendon with small defects [16]

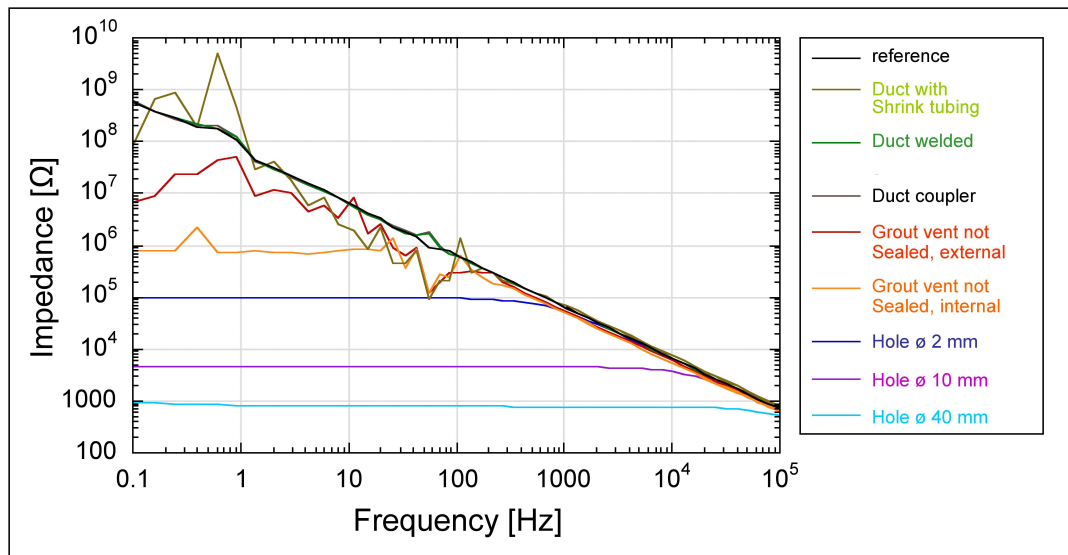
Fig. 3.: Impedance spectra (Bode plot) of the grouted ducts with different defects in concrete. Amplitude 10 mV. From ref. [16, 28].

The impedance spectra of the ducts with different defects are shown in figure 3. The general trend in the Bode plot is a straight line with slope -1 (representing the capacitance according to eq. 2). In these laboratory tests the capacitance values of all the ducts – irrespective if a defect is present or not – are identical, a value of 2.34 ± 0.04 nF was measured. A defect in the duct is represented by a resistance (horizontal line in the plot). As can be seen, a low resistance indicates a very severe defect (e.g. hole of 40 mm). The results of the ducts with the different defects are given in table 1. Note that the direct current (DC) resistance of ducts without defects is nearly infinite.

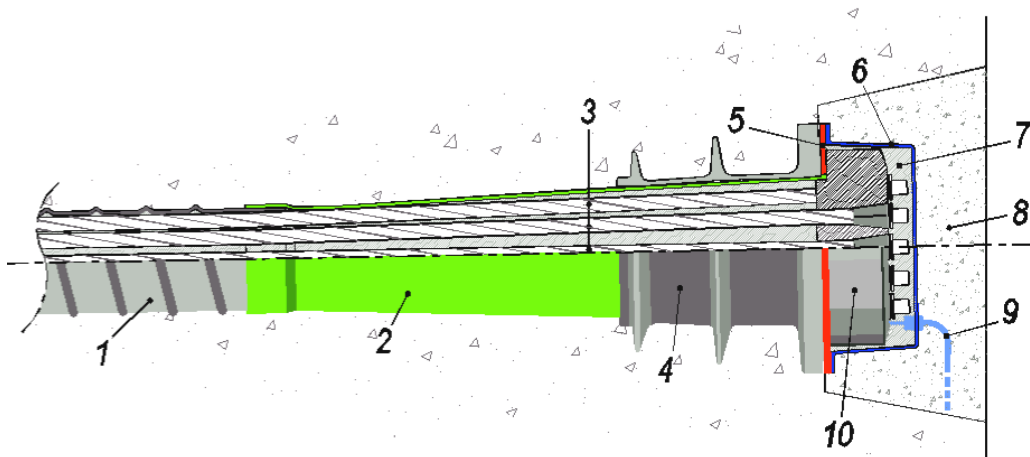
Anchoring of seven-wire pre-stressing strands using threaded wedges is a well-proven technology. Detailing is most important near the anchorages (Fig. 4) in order to guarantee complete encapsulation and electrical isolation. Between the steel anchor head (item 10) with the wedges that block the strands (items 3) and the cast iron bearing plate (item 4), a mechanically resistant insulation plate (item 5) is placed in order to electrically isolate the tendon from the normal rebar network. Inside the anchorages a plastic trumpet (item 2) tightly connected to the duct (item 1) isolates the strands from the cast-iron bearing anchorage.

Figure 4. Principle of electrically isolated anchorage (description of the numbered items in the text).

According to the Swiss guideline [14], the anchor heads are protected by plastic caps (item 6) and fully grouted (item 7). An electrical terminal (item 9) is drawn out from the head anchorage for impedance measurements. Minimum cross-section area of the electric terminal shall be 6 mm^2 for railway bridges with alternating current traction, 1 mm^2 in other cases. The anchorage shall be in accessible position (even if covered with second step casting for further protection) and the box collecting all electric terminals of a single deck shall be in areas easily accessible for inspection and maintenance personnel.

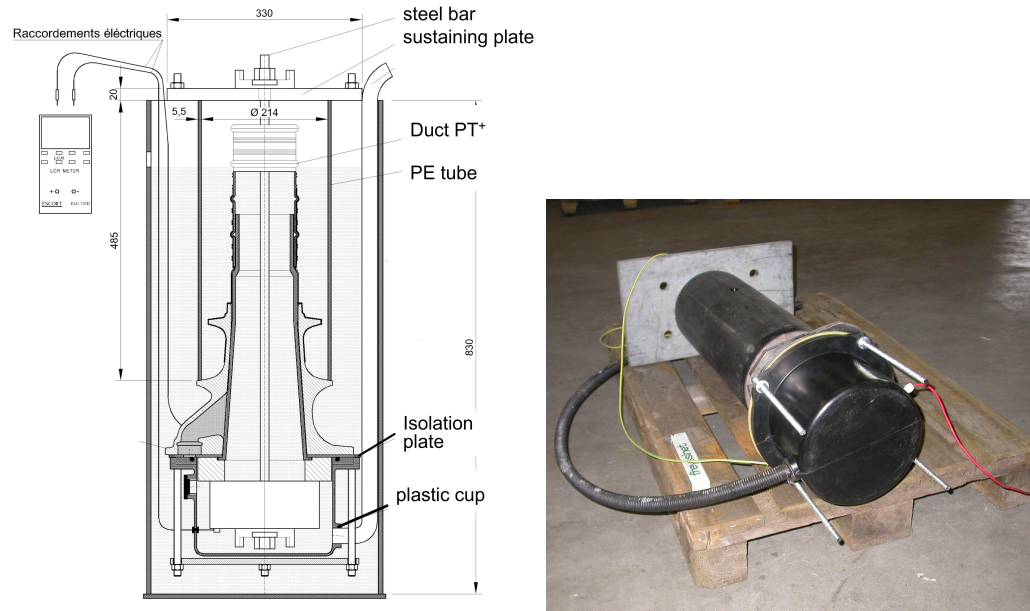
Figure 5: Test rig for the electrical resistance testing of electrically isolated anchorages

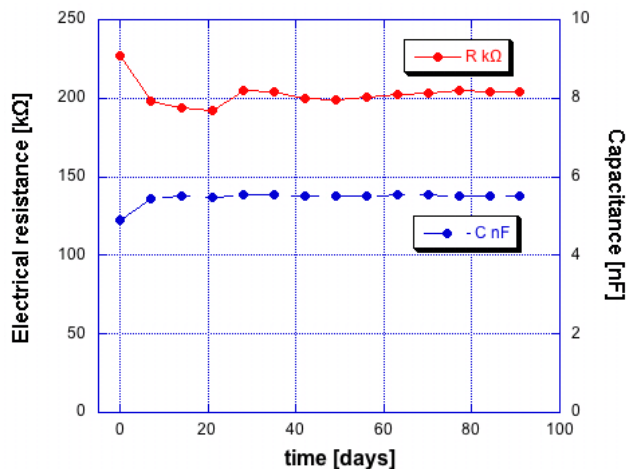
The pH of the test solution remained constant at $\text{pH} > 12$ over the testing period of 3 month. The electrical resistance measured between the central steel bar and the anchor head was constant at $200 \pm 5 \text{ k}\Omega$ over the testing period of 3 month (figure 6).

Figure 6: Evolution of electrical resistance and capacitance with time

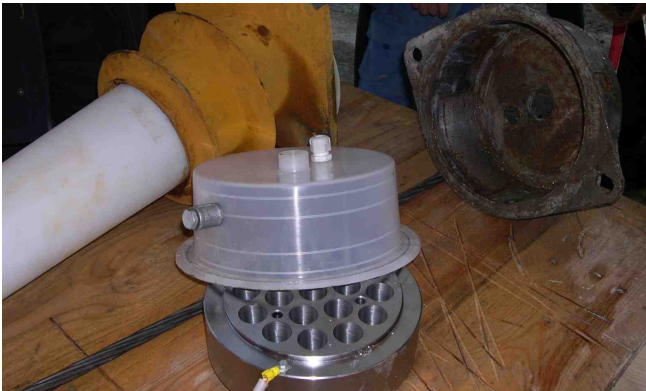
- The use of a *transparent cap* on the anchor head allows to check visually the grouting execution of the caps at the end of the grouting (figure 7) and, if necessary, re-grout from an additional inlet at the highest point of the caps before covering them permanently.
- Actually, the Swiss guideline leaves to the designers the choice to cover the anchorage caps with concrete or not. As a means of further protection the anchorages should be completely surrounded by concrete.

Figure 7: *Transparent cap of the anchor head used in the prefabricated elements of the segments of Piacenza Viaduct (Foto V. Nicollier [19])*

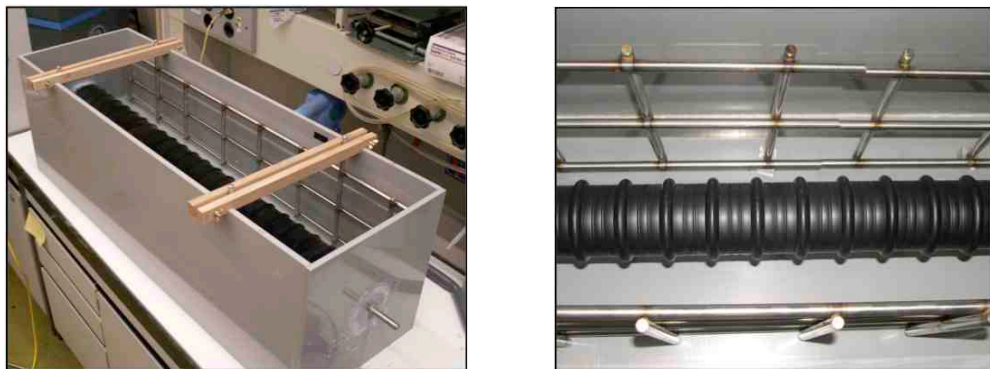
Figure 9: Experimental setup for the impedance measurements on the polymer ducts [19]. Note the stainless steel grid used as counter electrodes

The impedance was measured with a LCR meter (6451 LCR databridge) at frequencies of 0.1, 1 and 10 kHz between the reinforcement in the duct and the stainless steel counter electrodes placed in the basin (Figure 9). The measurements were performed 28 days after grouting.

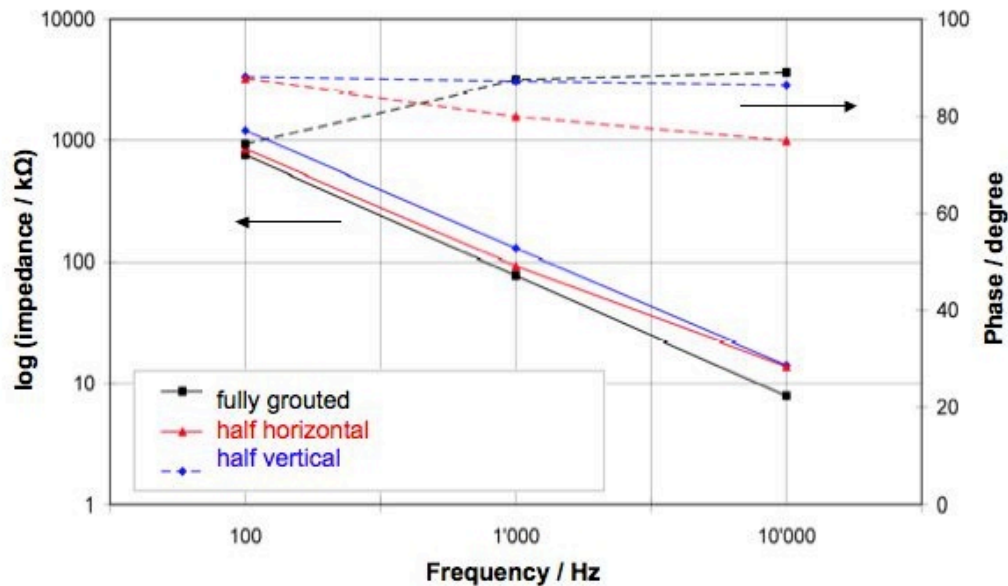
The results of the impedance measurements on the three samples with different grouting are shown in figure 10. The results of resistance R , capacitance C and loss factor D are shown in table 3. The phase angles are very close to 90 degrees and the impedance values decrease by a factor of 10 per decade frequency, thus indicating the typical behaviour of a capacitance. The fully grouted polymer duct shows the lowest impedance.

Figure 10: Impedance spectra in the frequency range from 100 to 10'000 Hz for the three differently grouted polymer ducts (see figure 8). Measurements performed after 28 days with LCR meter (6451 LCR databridge) [19].

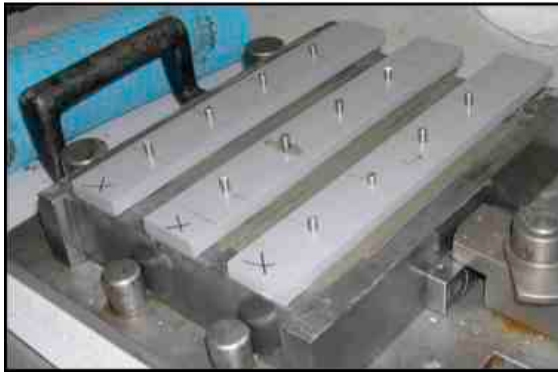
For the measurement of the evolution of the electrical resistance of grout mixtures 12 samples with dimensions of 160 x 40 x 40 mm were cast (figure 11a). In the samples stainless steel measuring pins (\varnothing 4 mm) were mounted before grouting.

Figure 11: Samples of grout mixture for measuring the evolution of the electrical resistance with time. a) moulds after filling with grout on the vibration table.

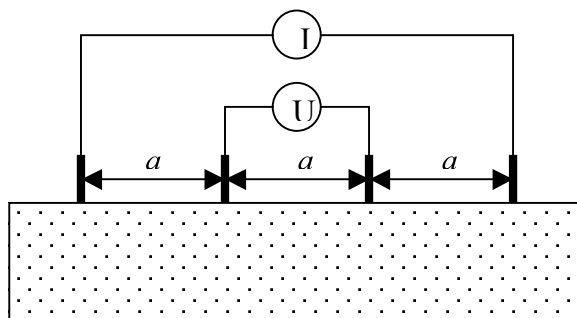
The 4-point measurement according to Wenner uses a 40 V 107 Hz AC signal. At the outer pins the current I enters into the sample, at the inner pins the voltage drop U is measured.

Figure 12: Principle of the electrical resistance measurement according to Wenner

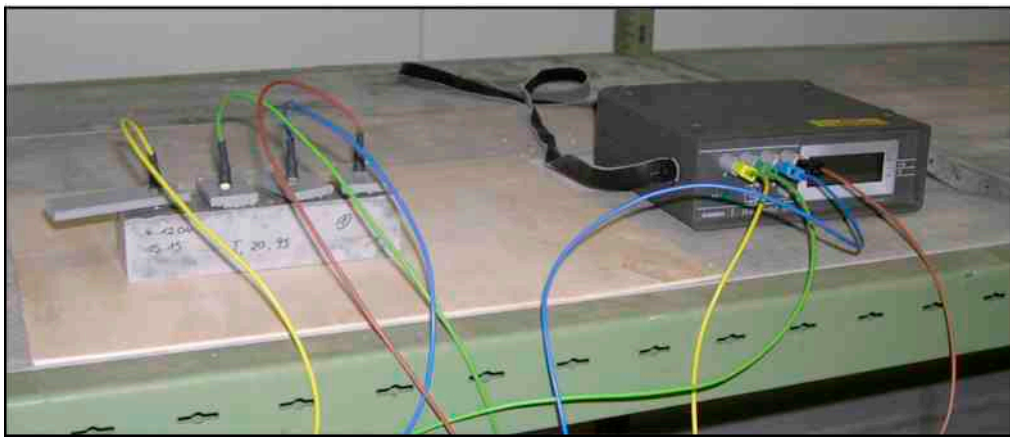
Measurements were performed with a four-point electrical resistance meter GEOHM (figure 13) at a frequency of 107 Hz to avoid interference with 16 2/3 Hz and 50 Hz AC line signals.

Figure 13: Measurement setup for the electrical resistance measurements

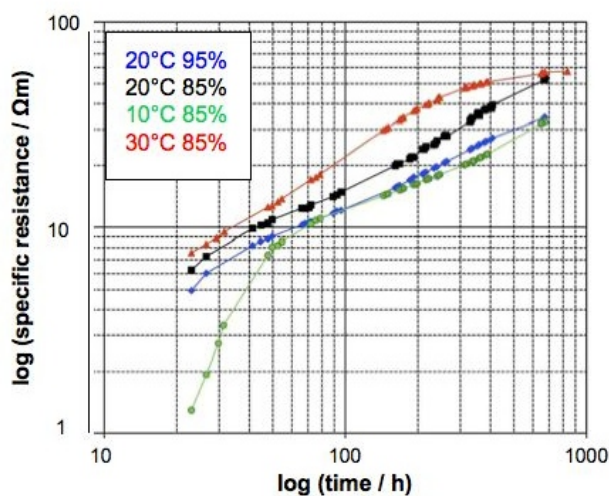
The evolution of the specific resistance (average over three samples each, standard deviation < 8%) of the grout mix for the different temperatures (10, 20 and 30 °C) and relative humidities (85%, 95%) with time is shown in figure 14 [19].

Figure 14: Evolution of the specific electrical resistance ρ for cement grout mixture at different temperatures and relative humidities (10 – 30 °C, 85% and 95% RH) [19].

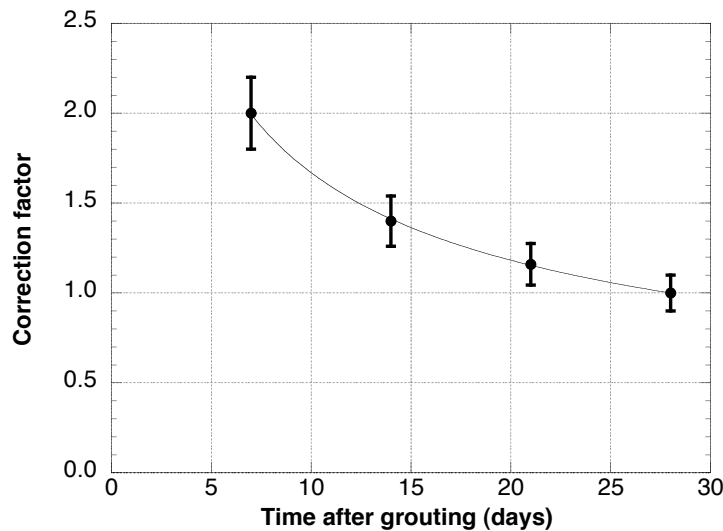
As an example: the specific resistance measured after 7 days has to be multiplied by $(28/7)^{0.5}$, thus a factor of two. The same information is given in the graphical representation in figure 15. These conversion formula and graph have been included in the revised Swiss Guideline [25].

Figure 15: Graphical representation of eq. (7)

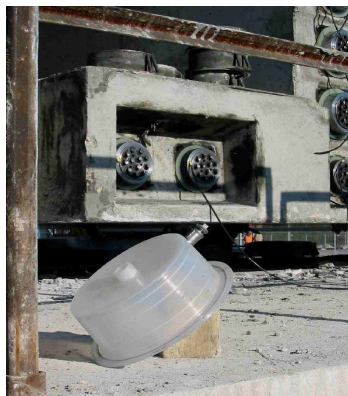
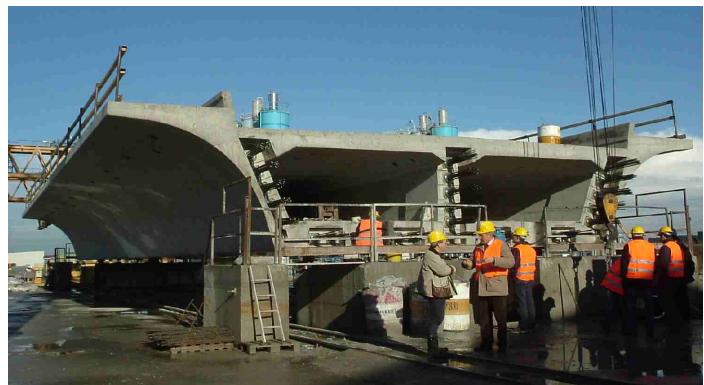
In the Italian high speed network the Piacenza viaduct (Fig. 16, 17) on the Milano-Bologna line is an example for full-span pre-casting of 151 simply supported pre-cast decks composed by a monolithic box girder with two cells, spanning 33.1 m and weighting about 1000 tons. The design of the elements and of the viaduct has been reported previously [18, 23]. Data have been collected from the first 71 decks of the Piacenza viaduct (fig. 17), each containing 9 cables with 12 strands, duct \varnothing 76 mm (in the lower slab) and 15 cables with 19 strands, duct \varnothing 100 mm (in the webs).

Figure 16: Piacenza viaduct anchorage and transparent stocking area [23]
Figure 17: Piacenza viaduct full span precast deck in anchorage [18].

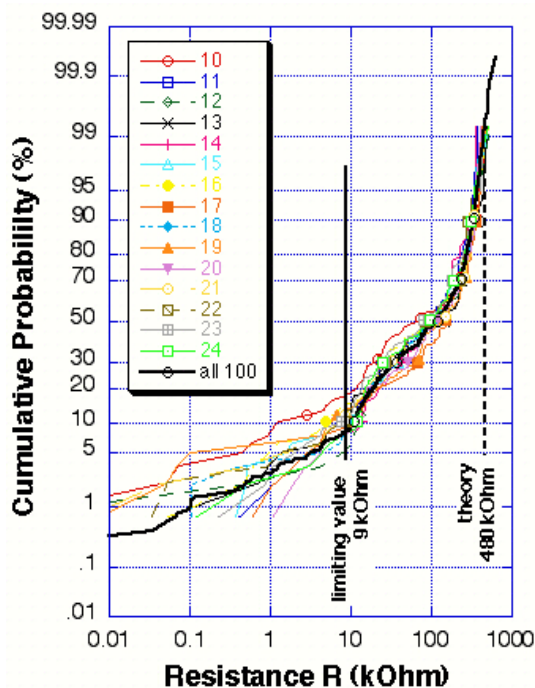
The statistical analysis of the measured resistance R on more than 1000 tendons is more complicated because the values – despite the constant length of the tendons – do not show a gaussian distribution. The analysis is thus performed with the cumulative probability plot (figure 18, 19). For the tendons with \varnothing 100 mm from the segments of the Piacenza viaduct (figure 18), less than 1% of all values are below 10Ω , thus cables with a short circuit (electrical contact between tendon and normal reinforcement). The minimum of the specific resistance $\rho = 300 \text{ k}\Omega\cdot\text{m}$ according to [14] results in a lower limit of the electrical resistance $R = 9 \text{ k}\Omega$ for the tendon with length 32.1 m.

Figure 18: Cumulative probability distribution of the resistance R , measured for 19 strands E.I. cables in 71 Piacenza viaduct decks.

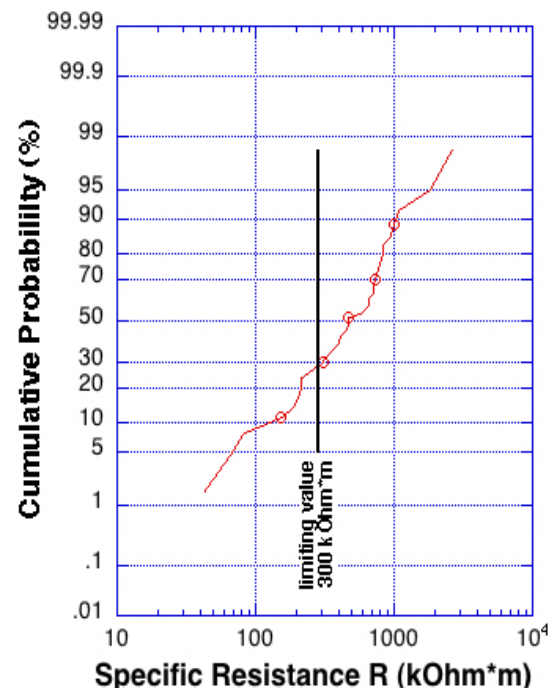
Figure 19: Cumulative probability distribution of the specific resistance ρ , measured for 19 strands E.I. cables in 33 Marchiazza viaduct decks.

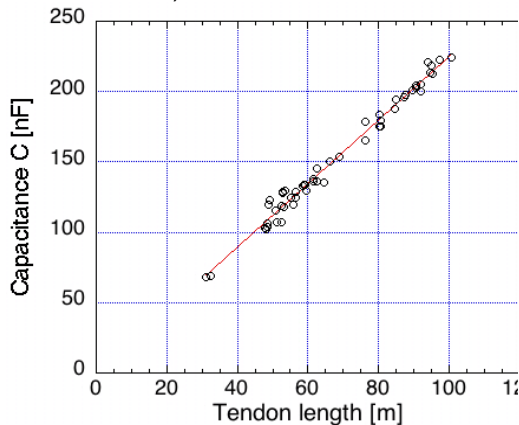
This flyover constructed for a highway link with about 60 EIT tendons of different length showed that the capacitance values of the individual tendons are proportional to the tendon length L as expected (Figure 20). From the slope of the diagram a value of $C = 2.35$ nF/m was obtained in good agreement with laboratory results. The results of the resistance values R (multiplied by the length of the tendons) showed values from 10 to 1800 k Ω m. In the cumulative probability plot (Figure 21) clearly two distributions (lines) could be observed: the one at high R values was associated with “good” tendons (acceptance criteria fulfilled). However, ca. 50% of the tendons did not reach the acceptance criteria.

Figure 20: Capacitance C of the individual EIT tendons in a flyover near Basel as a function of the tendon length. Diameter of plastic duct 59 mm

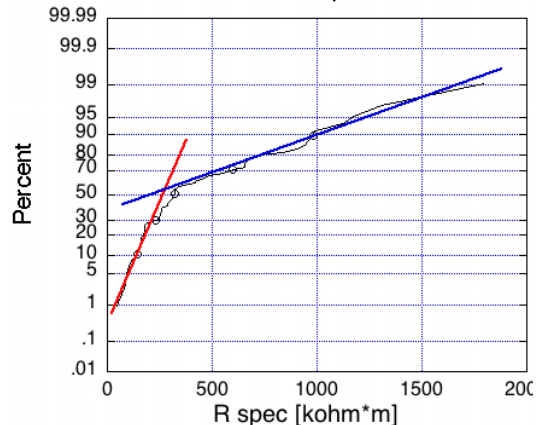
Figure 21: Cumulative probability plot of the resistance values measured for EIT tendons in a flyover near Basel. Diameter of plastic duct 59 mm.

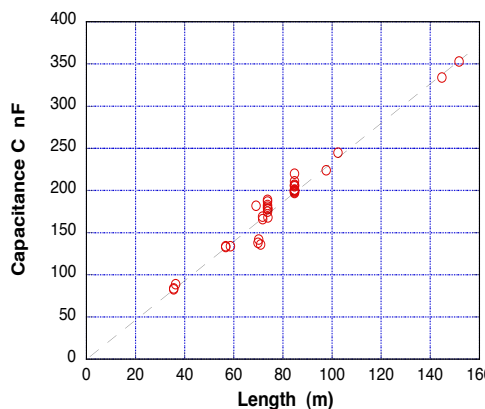
This series of viaducts near Zurich airport were built for the new tramway connection. Electrically isolated tendons were mandatory due to the expected stray currents (DC current for the traction). Measurements on one viaduct with about 45 EIT tendons of different length between 37 and 150 m confirmed that the capacitance values of the individual tendons are proportional to the tendon length L as expected (Figure 22).

Figure 22: Capacitance C of the individual EIT tendons in a viaduct near Zurich airport as a function of the tendon length. \varnothing 59 mm

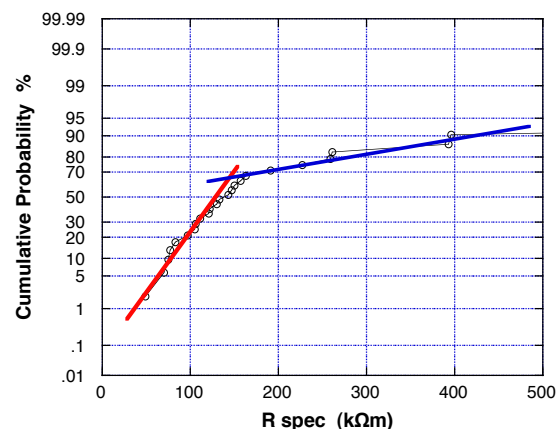
Figure 23: Cumulative probability plot of the resistance values measured for EIT tendons in a viaduct near Zurich airport. \varnothing 59 mm

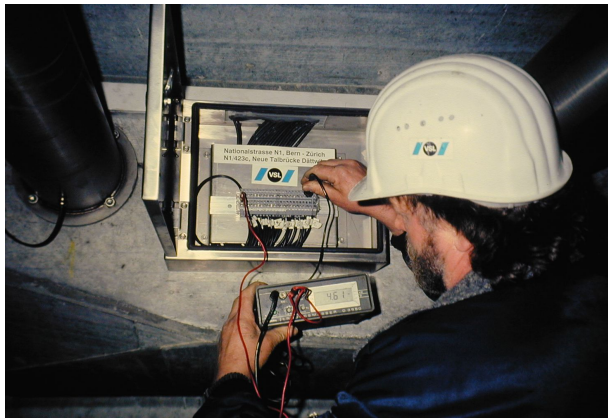
The measurements require a sound electrical connection to each individual tendon (preferably mounted to both of the end anchorages) and another connection to the reinforcement. All the connection wires usually are concentrated in a box easily accessible (Fig. 24). Monitoring of the electrically isolated tendons was performed with AC impedance measurements at frequency of 120 Hz and 1 kHz. A small portable and battery driven instrument (LCR meter ESCORT 131) measures the real and imaginary part of the impedance of the tendon under test. The instrument calculates and displays the ohmic resistance R , the capacitance C and the loss factor D for the measuring frequency chosen.

Figure 24 : Measuring box

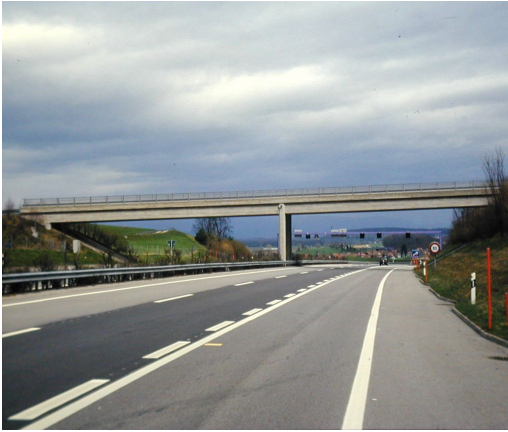
As an example the flyover “Pré du Mariage” (Figure 25) is presented. It is a relatively simple, short box girder structure with only one column in the middle. Six electrically isolated tendons of \varnothing 76 mm and length 49.3 m were used. At “Pré du Mariage” electrical impedance measurements have been performed at frequent intervals since the time of grouting. The evolution of the electrical resistance with time is shown in figure 26. As can be noted, the values for the six individual tendons show a certain scatter, but the overall trend is an increase of the electrical resistance with time. In the $\log R$ vs $\log t$ plot a straight line with slope 0.5 is found.

Figure 25: Flyover “Pré du Mariage” near Avenches (highway A2 Switzerland)

This is equivalent to the normal square root law indicating that the increase in resistance is very rapid at the beginning and slows down after some month. This trend is expected to continue, with some variations due to temperature, for all tendons and for the entire future service life of the structure. Deviations from the expected trend, a decrease in the resistance of one or several tendons, allows detection of the ingress of (chloride containing) water at a very early stage: if water reaches a defect in the duct, the concrete and the grout near the defect get wet and the electrical resistance of this specific tendon will drop [26, 27].

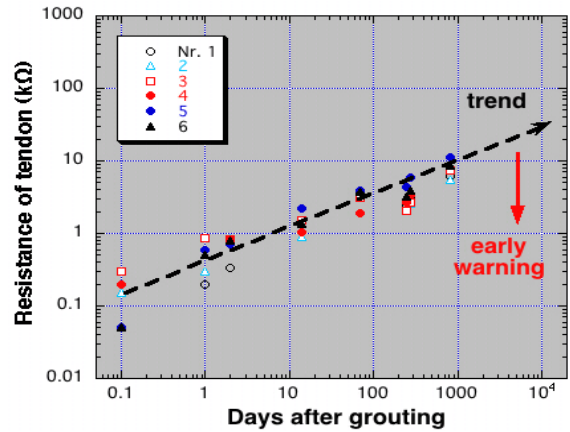
Figure 26: Evolution of the electrical resistance of the six tendons of the flyover “Pré du Mariage” with time

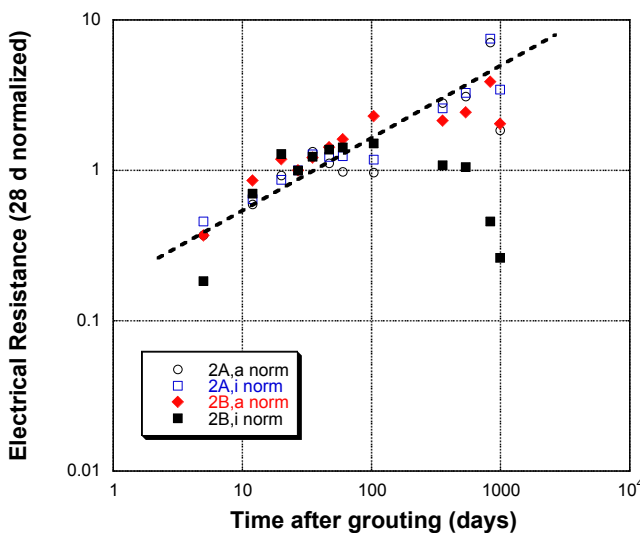
Another example of long term monitoring is a simple one span railway bridge of 23 m length with 12 tendons of 59 / 76 mm diameter near Lenzburg (AG, Switzerland) built in 2003. Measurements of the electrical resistance were performed in regular intervals. As the resistance of the individual tendons varied much more than in the “Pré du Mariage” (Fig. 26), the values were normalized with the value at 28 days. This allows following the evolution with time (Figure 27) much better. As can be seen, three of the four tendons represented follow the trend line with slope 0.5, indicating an asymptotic increase of the electrical resistance with time and no sign of water ingress. Only one tendon shows continuously decreasing values of the normalized resistance, indicating that at least at one of the defects water (and probably also chloride ions) are penetrating into the grout.

Figure 27 : Evolution of the normalized electrical resistance of four tendons of the bridge “Muhen” with time

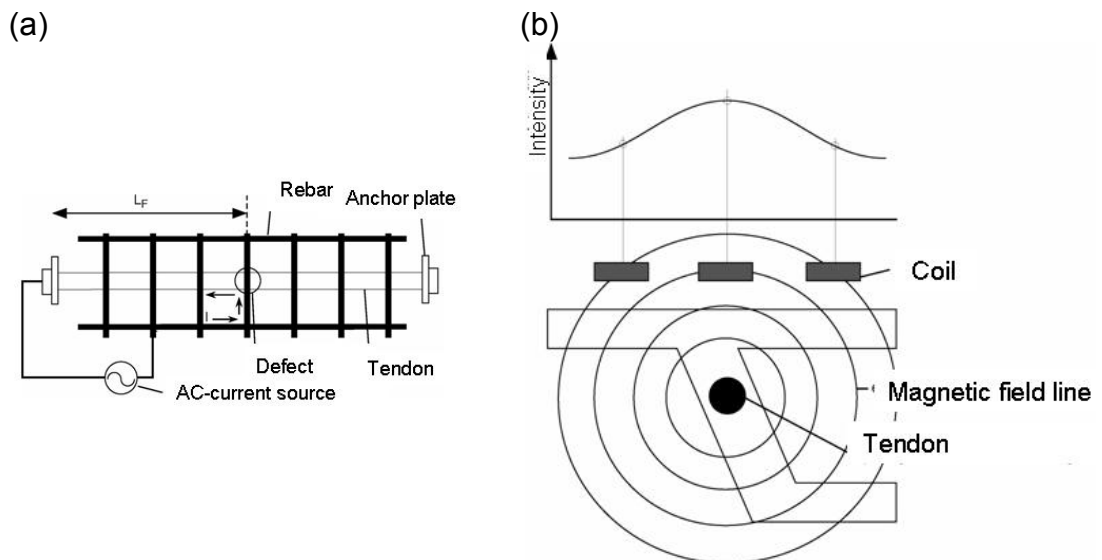
Imposing an AC electric field between the high strength steel and the reinforcement (using the electrical connections provided for the impedance measurements), a current is flowing through the tendon. Measuring the magnetic flux of the resulting AC-current (figure 28) allows determine the areas with current flow and, as a consequence, to locate the preferred sites (short circuits) where the current is leaving the tendon. Hence, this measurement allows detecting the areas with lowest resistivity of the isolation of the tendon. A schematic representation of the experimental setup is shown in figure 28a and b.

Figure 28: Detection of the magnetic flux created by a current in the tendon. a) Experimental setup for the measurement. b) Dependence of the result on the measuring position relative to the tendon.

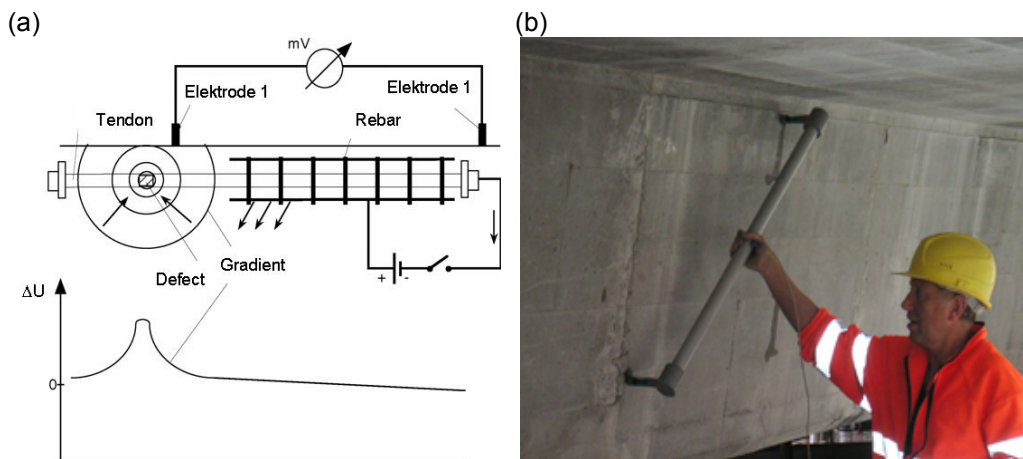
Figure 29: Detection of the ohmic potential drop caused by current leaving the defect. a) Experimental setup for the measurement. b) Application in the field.

Defects in the insulation of the tendon can be located only in the absence of a direct metallic contact between the reinforcement and the tendon by measuring the potential drop on the concrete surface along the tendon (Figure 29).

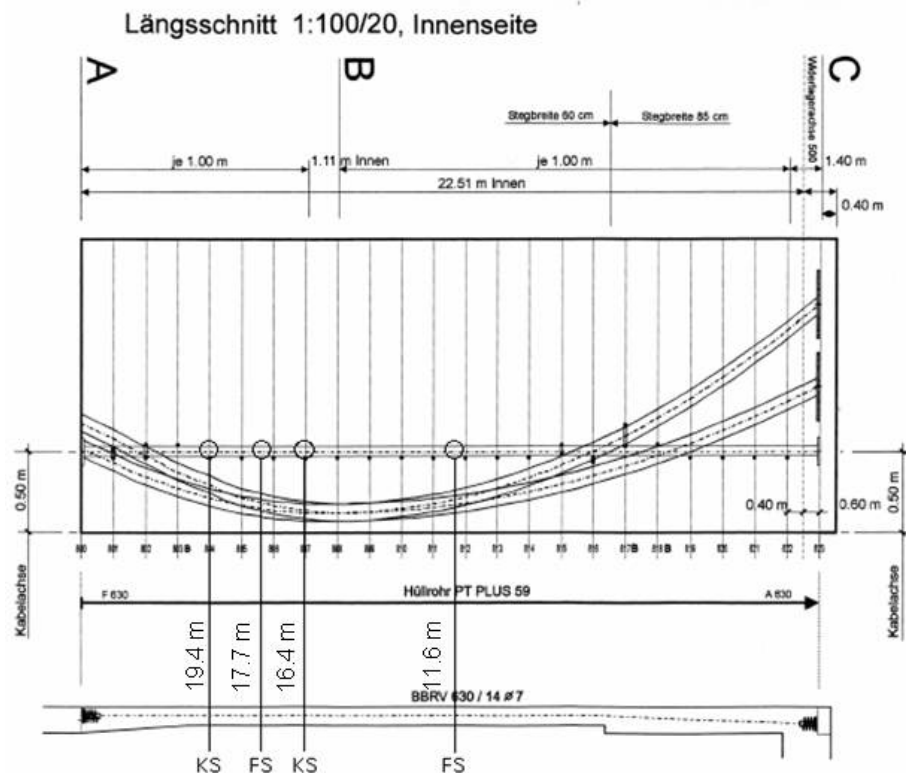
In order to calibrate the measurements, simulated defects were introduced in concrete elements for laboratory investigation. Moreover a bridge was equipped with an additional tendon (Figure 30). For the measurements the AC current source and the detector unit CL20 from Baur was used in all measurements. The frequency was 815 Hz in all measurements.

Figure 30: Additional horizontal tendon equipped with holes (FS) and contacts to the reinforcement (KS) that can be electrically opened.

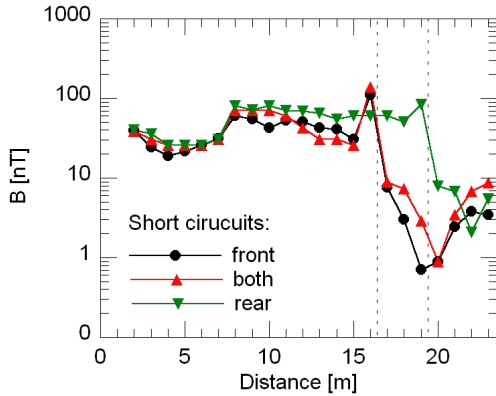
The results of the location of a metallic contact between rebar and tendon on the bridge equipped with a tendon that contains artificial defects are shown in figure 31. The measurement of the magnetic flux B was performed walking over the bridge deck with the detector. Different configurations with only one (front and rear contact) and both contacts were investigated. The reference point of the measurement was the anchor head at the end of the structure. Clearly a decrease of the magnetic flux is found at the location of the contact. This is due to the fact that the current is leaving the tendon at this point. The detection of a single contact is readily possible while in presence of two contacts a reliable detection of both of them is difficult.

Figure 31: Distribution of the magnetic flux along the tendon installed in a bridge with different metallic contact configurations.

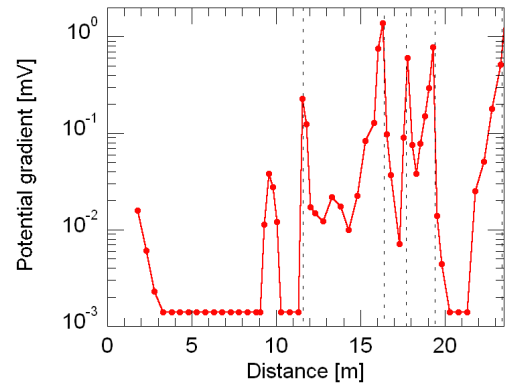
Figure 32: Potential drop on the concrete surface caused by the current flow from the tendon to the rebar. The vertical lines mark the area with the introduced defects (cf. Figure 30).

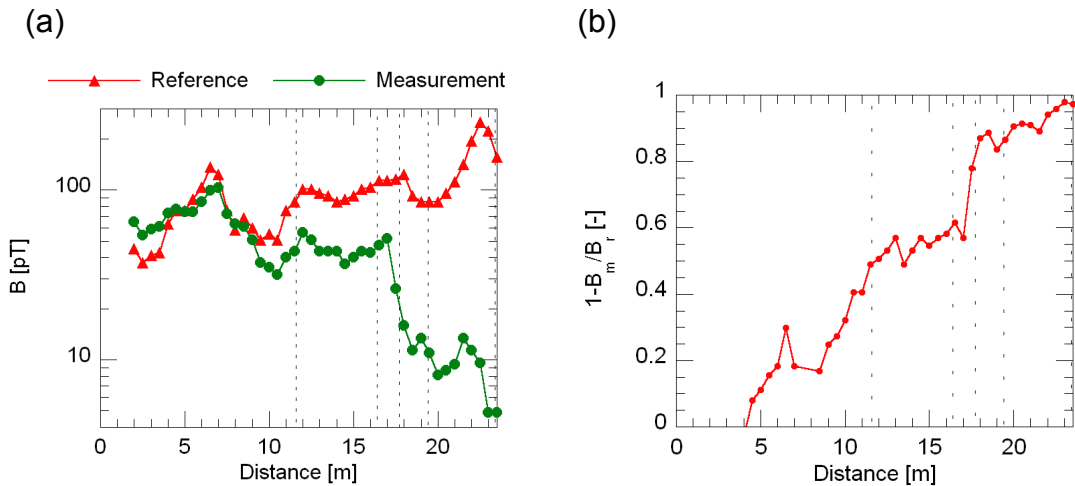
Figure 33: Measurement of the magnetic flux along the tendon. a) Results for a reference and the actual measurement without any connections to the rebar. b) Correction of the data in (a).

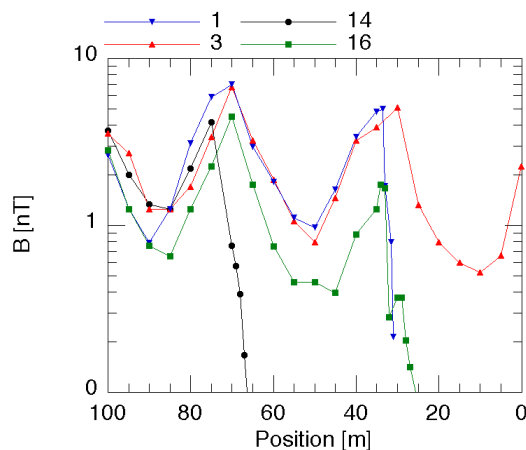
Figure 34: Measurement of the magnetic flux along the tendons in a bridge with 100 m length.
