Figure 1: SCOPE SHM platform

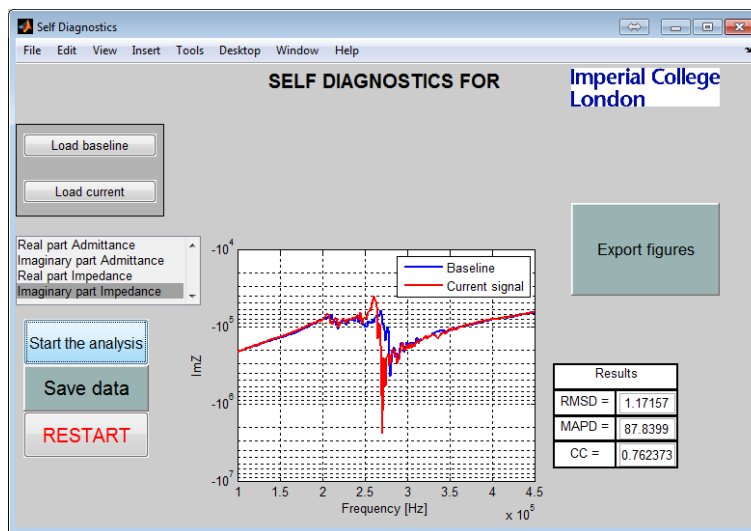
Figure 2: Self-diagnostic module - SCOPE platform

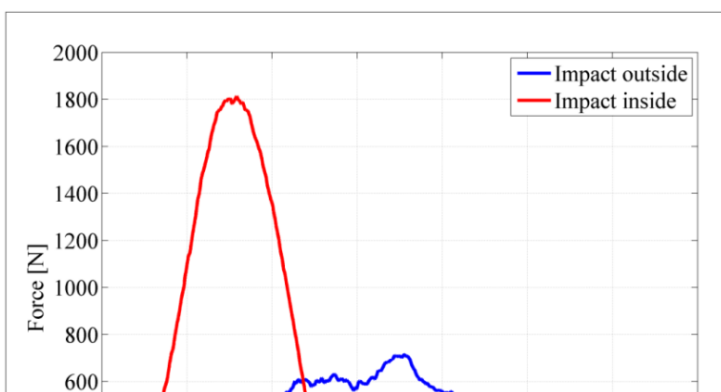
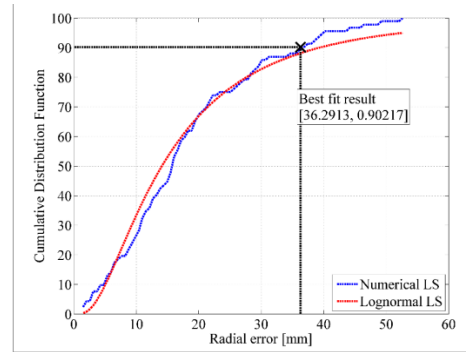
(b) POD for impact location, outer panel

(a) Contact force

(c) POD for impact location, inner panel

Figure 3: Examples of impact force caused from impacts on inside and outside of the panel

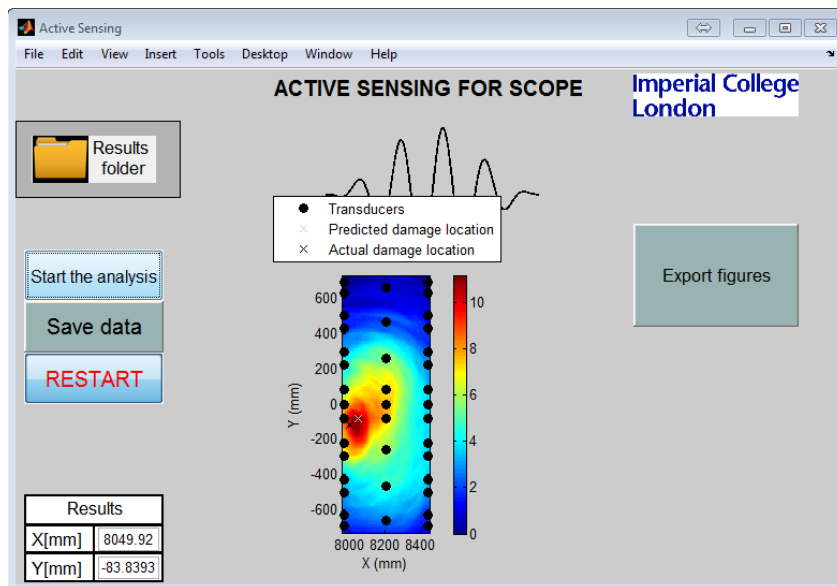
Figure 5: Active sensing module - SCOPE platform

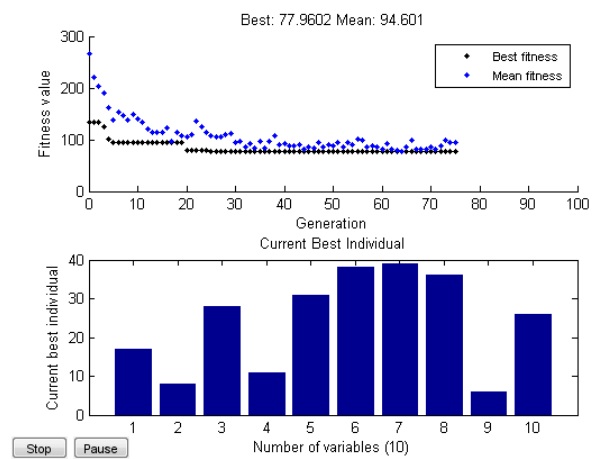
(a) Best 4 sensors placement in the central bay

(b) Example of GA results

Figure 8: Example of GA results.

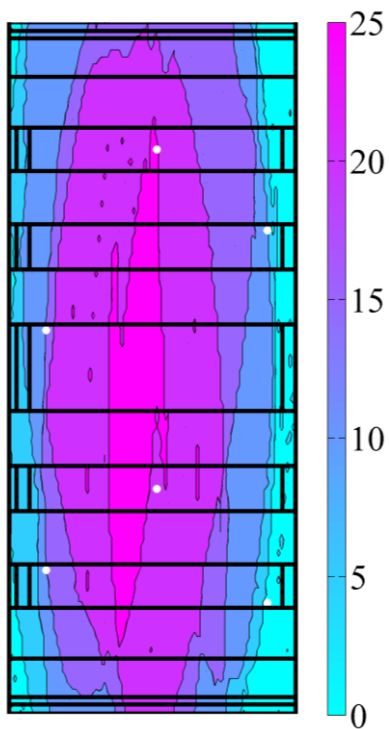
39 possible sensor locations

Figure 10: Coverage and positioning for 6 sensors

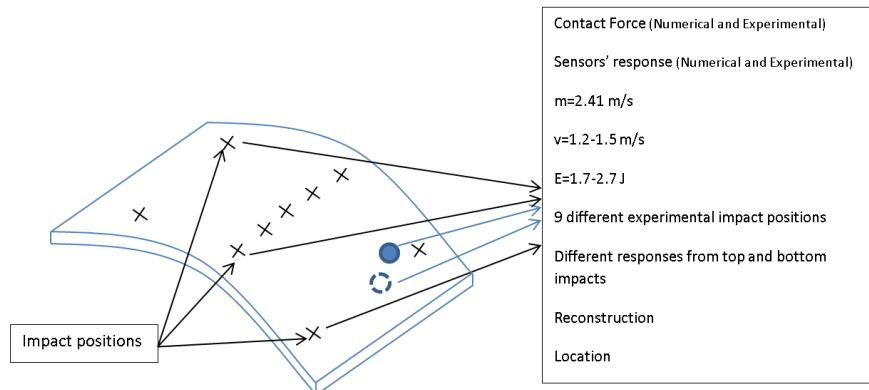
Figure 11: Building block approach for validation of passive sensing.

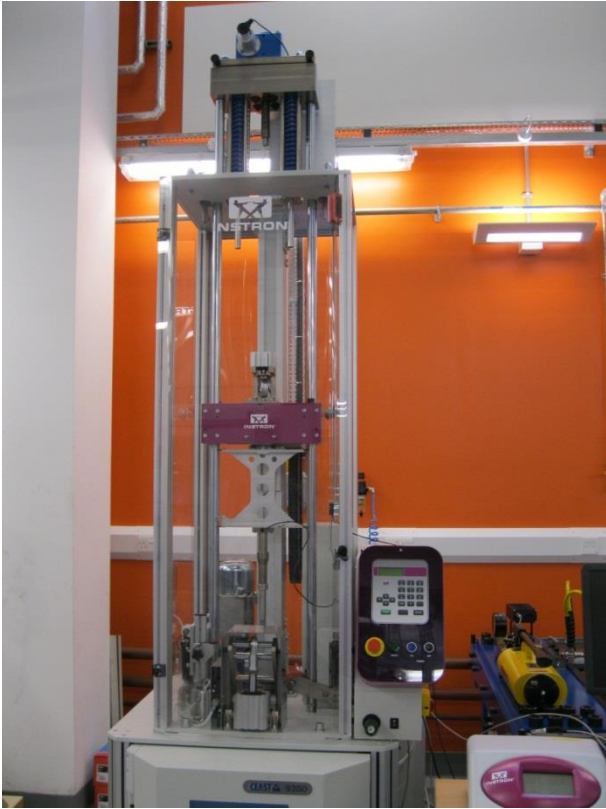
Figure 12: Drop tower used for the validation of passive sensing.

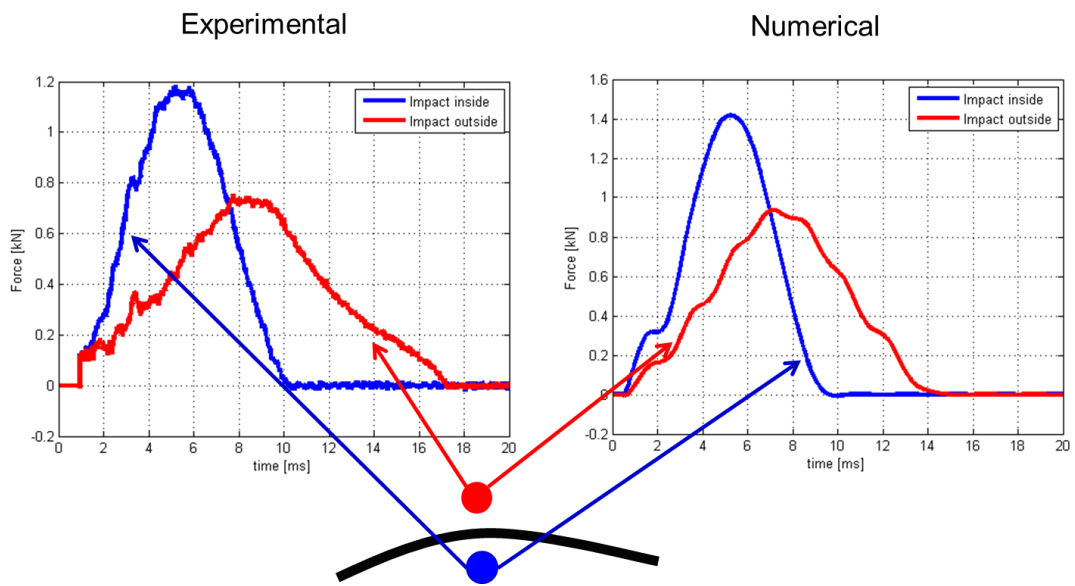
Figure 13: Validation of contact force.

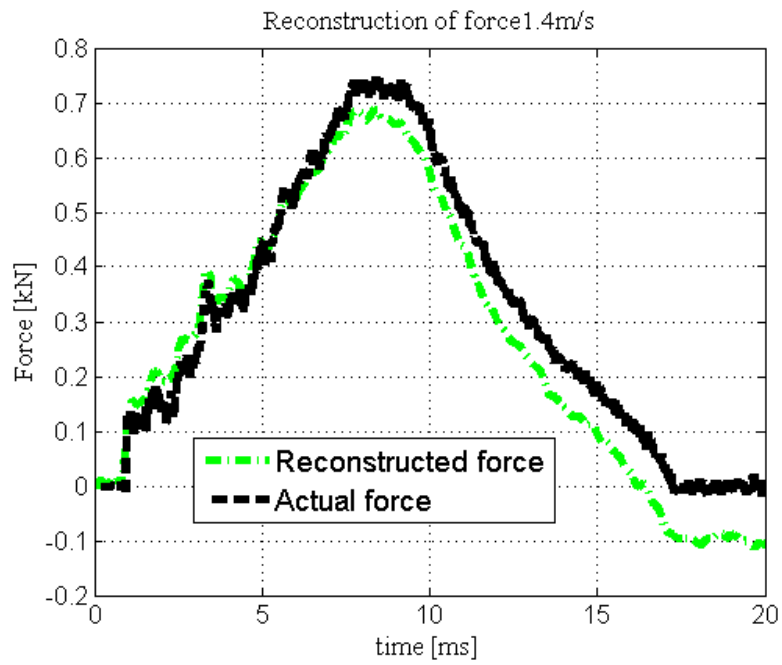
Figure 15: Experimental force reconstruction.

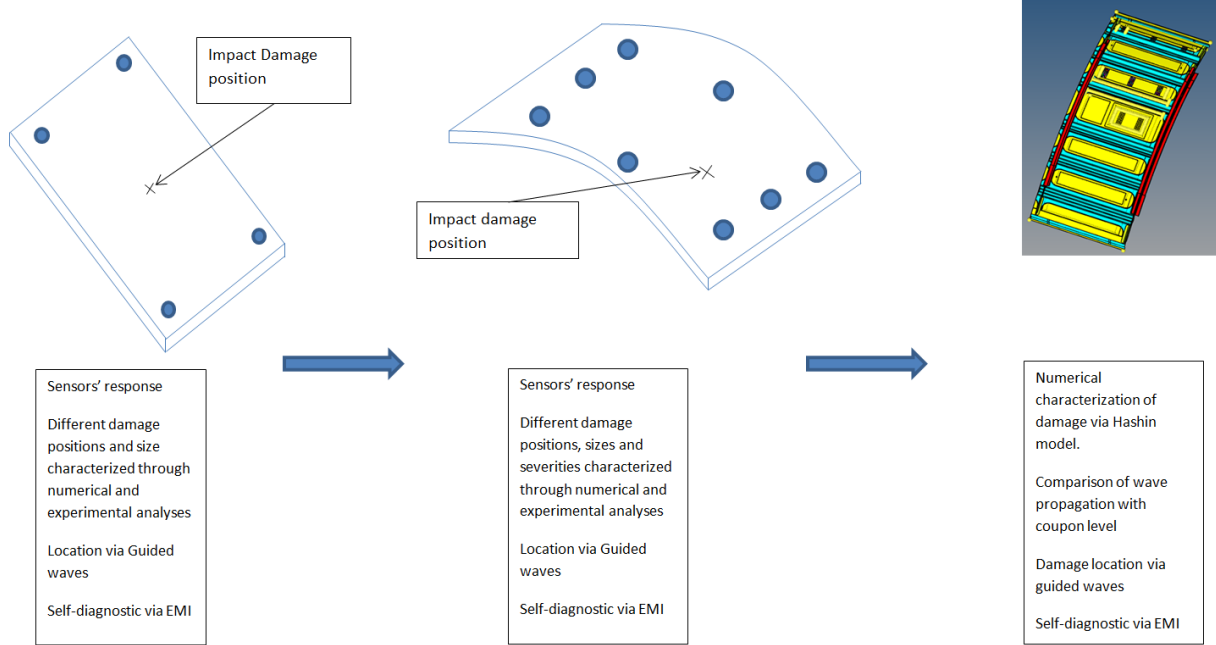
Figure 16: Validation approach for active sensing.

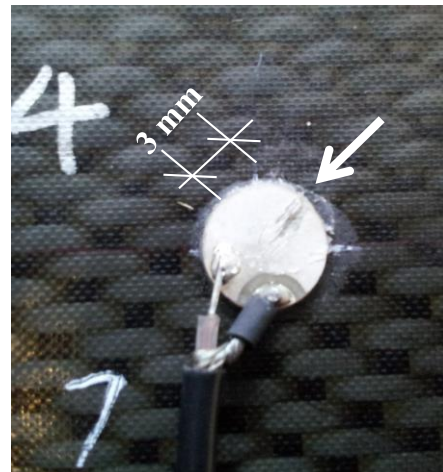
(a) Crack 1

(b) Crack 2

Figure 18: Self-diagnostics via EMI for a cracked PZT.

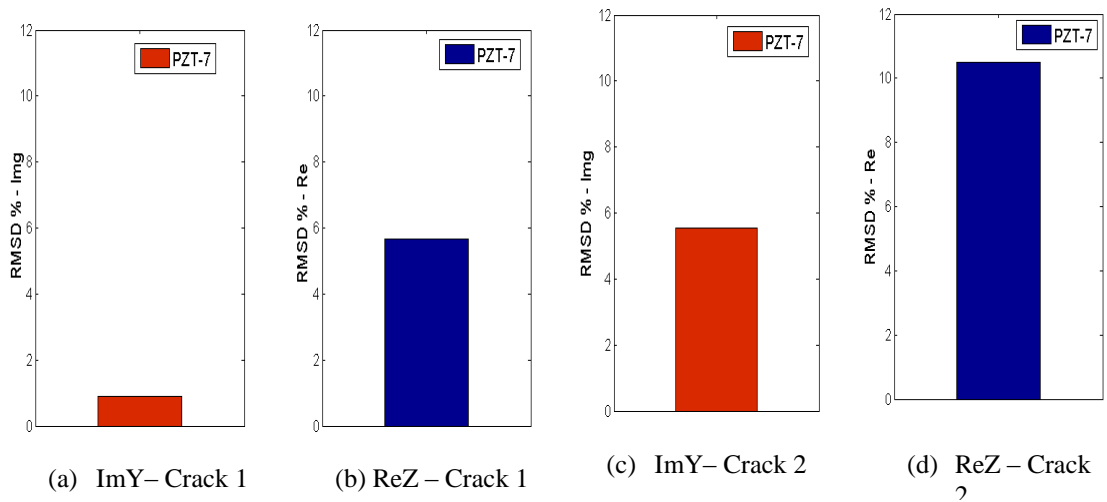
(a) ImY - Crack 1

(b) ReZ - Crack 1

(c) ImY - Crack 2

(d) ReZ - Crack 2

Figure 19: Crack evaluation via RMSD.

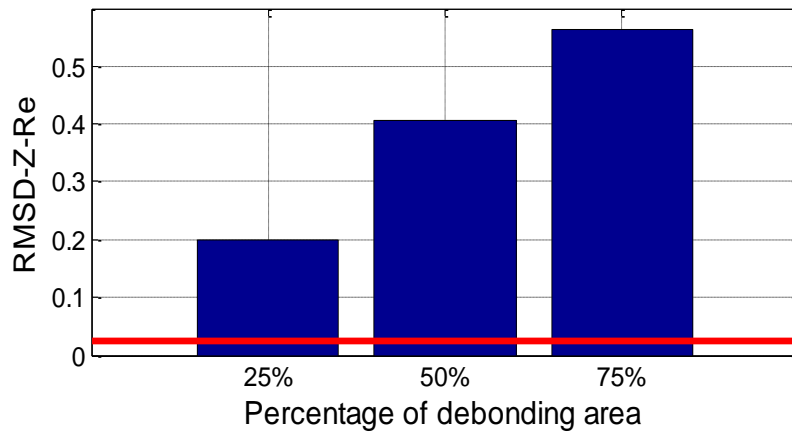
Figure 21: Debonding evaluation via EMI.

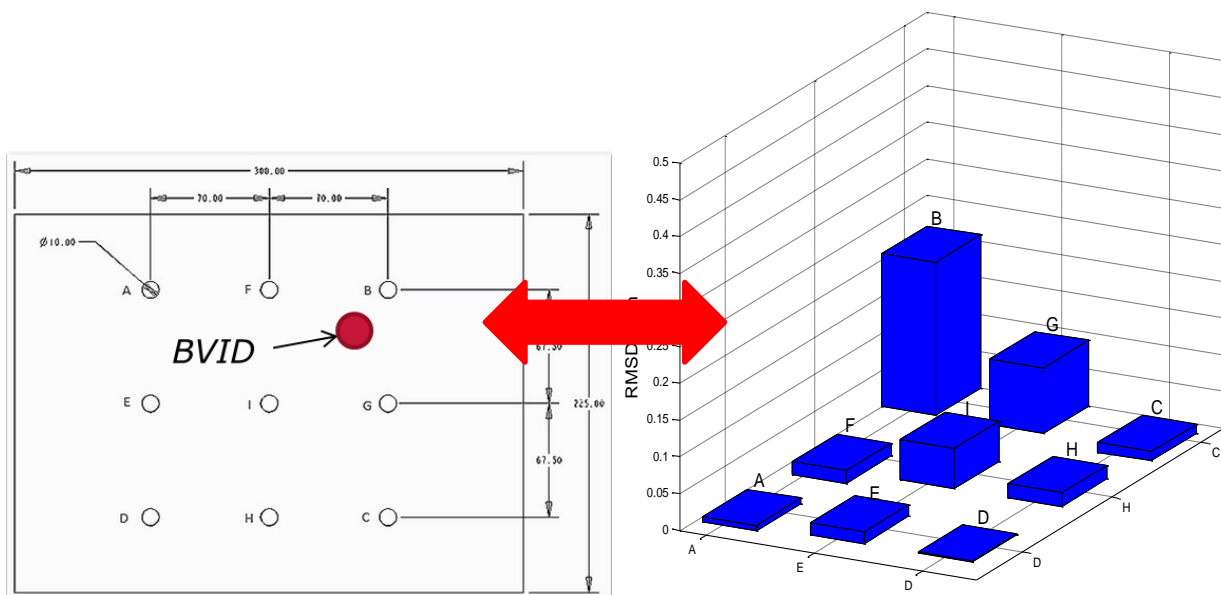
Figure 22: Damage evaluation at coupon level via EMI.

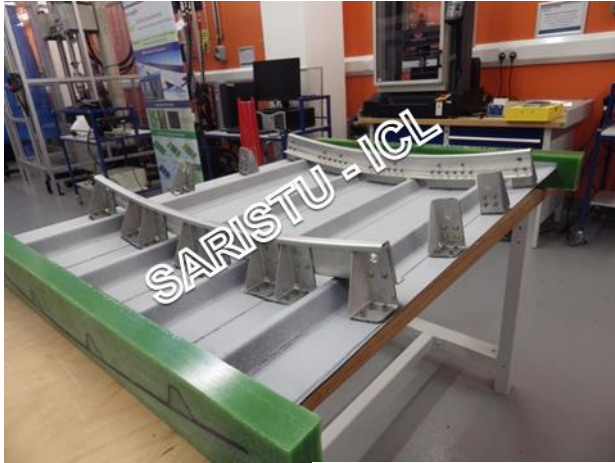
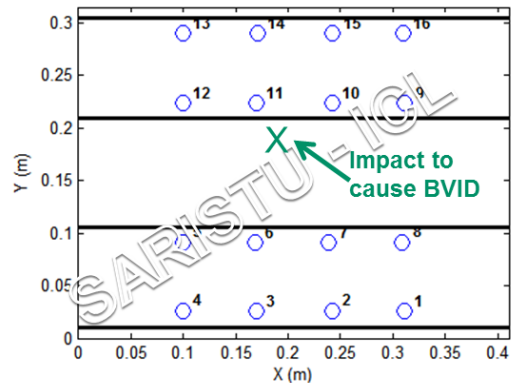
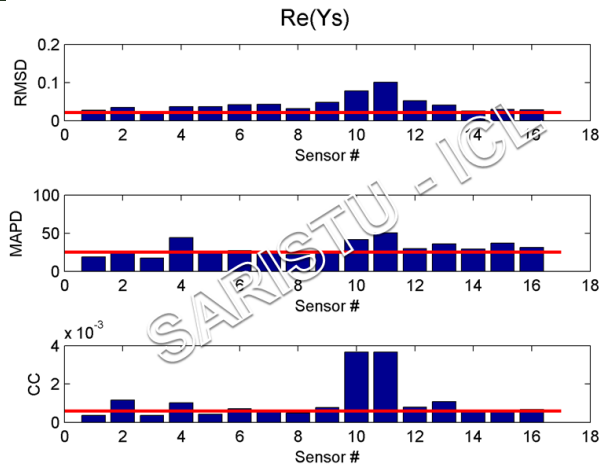
Figure 23: Damage detection via EMI at sub-component level [14].

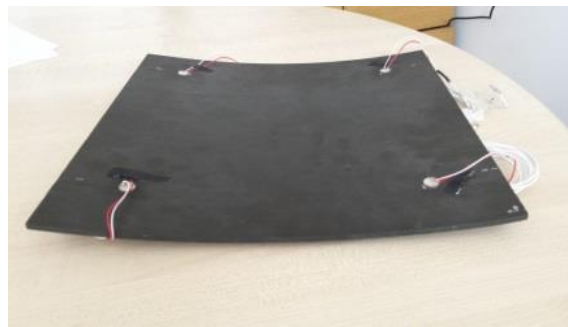
Figure 26: Curved coupon panel under analysis.

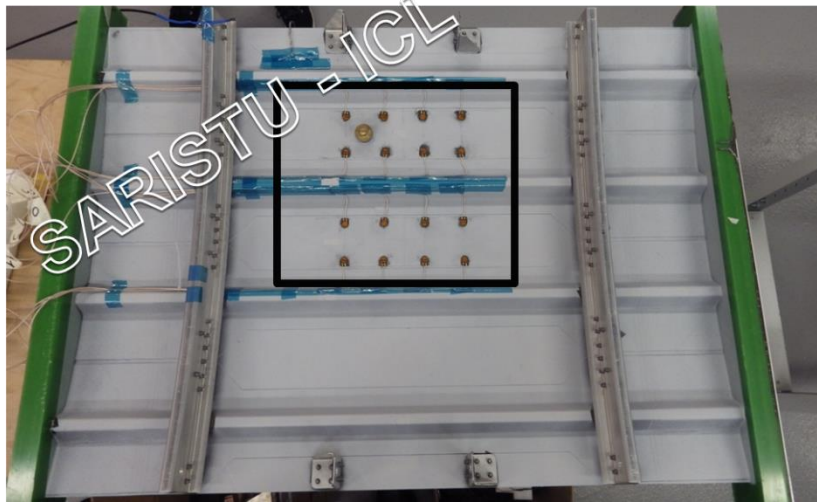
Figure 29: Sub-component specimen with PZTs installed on its inner surface [15].

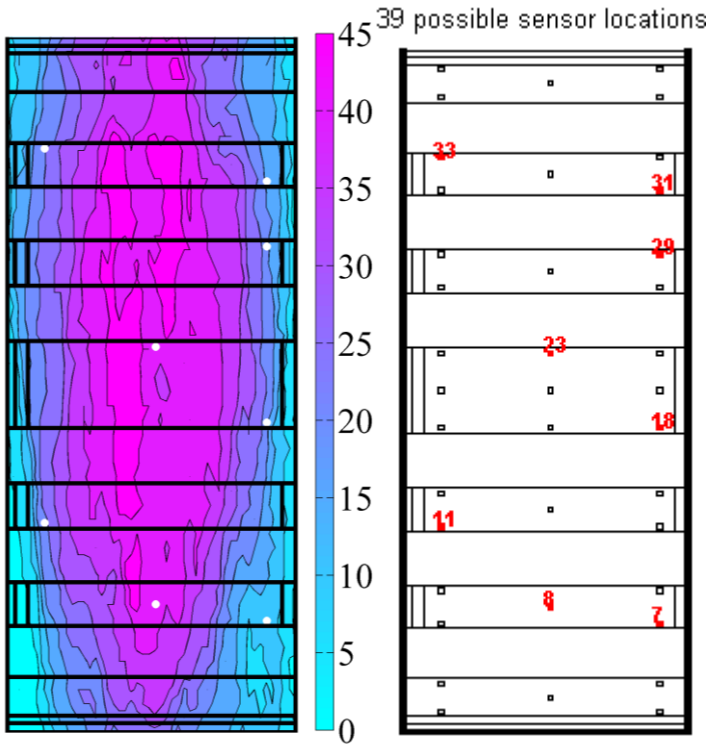
(a) Coverage area of the optimal 8 sensors

(b) Optimal positioning for 8 sensors

(c) Comparison between optimal and random placement for damage detection

Figure 31: Validation of Optimal sensor placement - Active sensing
