Ministry of Infrastructure and the
Environment

Monitoring Traffic Safety

Longer and heavier vehicles

Datum July 2011
Status Final

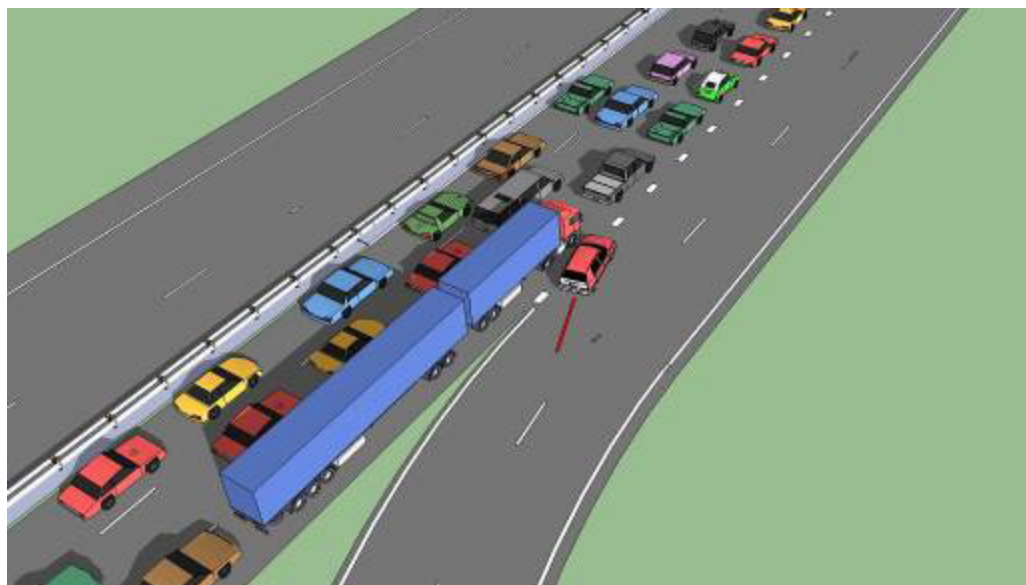
Upon merging onto the A15, a passenger vehicle from the A4 hit the front right side of the LHV, which was standing still on the A15. This caused a side collision with material damage only.

This accident possibly occurred because the driver of the passenger vehicle wrongly judged the length of the LHV upon merging on the A15. In view of the fact that the LHV was standing still, it is more likely that driver of the passenger vehicle failed to observe that traffic on the A15 was standing still, and subsequently merged at a point in the road where there was no room for this manoeuvre.

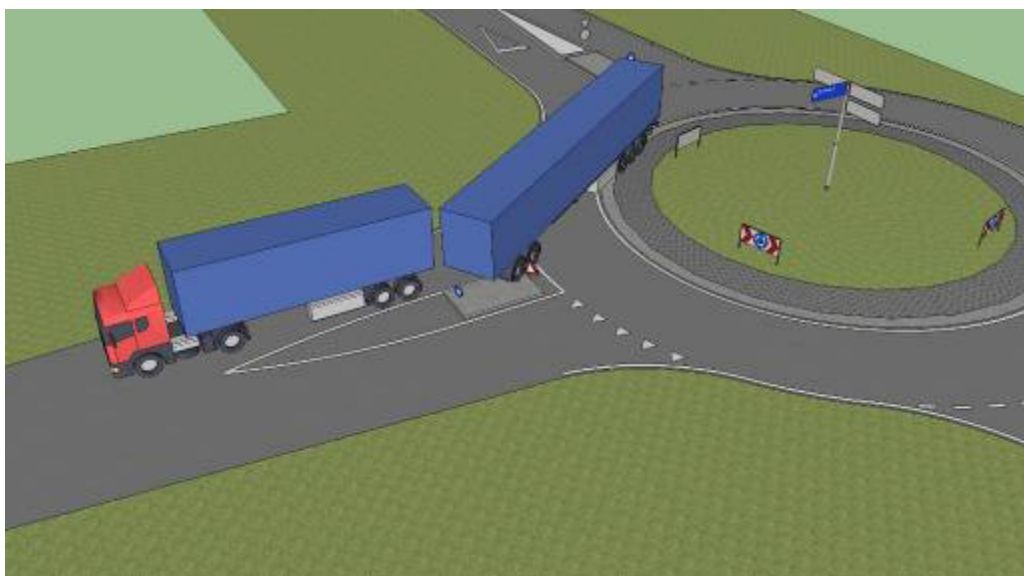
Upon negotiating three-quarters of the roundabout, the trailer separated from the rest of the combination upon exiting the roundabout. This caused the trailer to partially fall onto the road and onto the guide island on the roundabout. The trailer and the guide island with the traffic sign were damaged. No other vehicles were involved in this accident, which resulted in material damage only.

This accident occurred because the trailer was incorrectly connected, or because the attachment point was damaged while taking the roundabout. It is impossible to establish the exact cause on the basis of the police accident report. It should be noted that the LHV concerned had already travelled a great distance prior to the accident. This means it is highly likely that the sudden defect was the underlying cause of the accident.

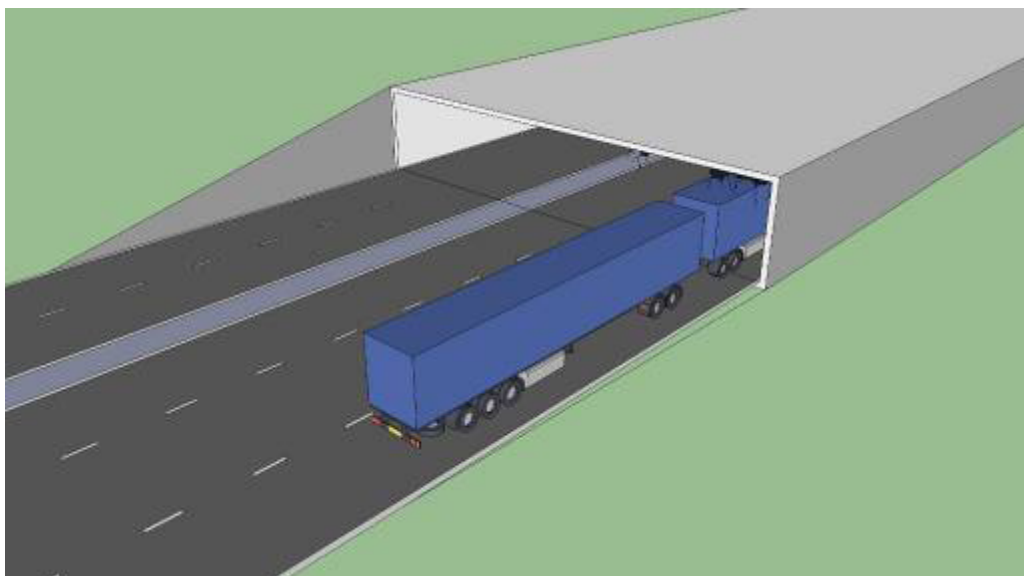
Upon entering the Thomassen tunnel, an exceptional transport vehicle, consisting of a trailer with a mobile caterpillar crane, crashed into the installations positioned on the tunnel's ceiling. The mobile caterpillar crane supposedly collided with the installations because a plate on top of the crane was not properly attached, causing it to stick upwards. The tunnel installations were separated from the ceiling and, 23 vehicles, among which the LHV, were subsequently damaged by the loose installations. This resulted in material damage only. The LHV was damaged on the front, right side and top.

This accident occurred because part of the metal plate on top of the mobile crane came loose. This caused the plate to protrude and damage the installations on the ceiling in the tunnel. Various other vehicles subsequently collided with the installations that were hanging loose, and were unable to brake in time to prevent a collision with these objects.

The accident could have been prevented, if prior to the journey, the mobile caterpillar crane had been checked properly so the loose component on the metal plate would have been discovered on time.

Considering the nature of the accident, it seems safe to conclude that specific LHV characteristics played no part in the accident. In addition to the LHV a large number of other vehicles were also damaged.

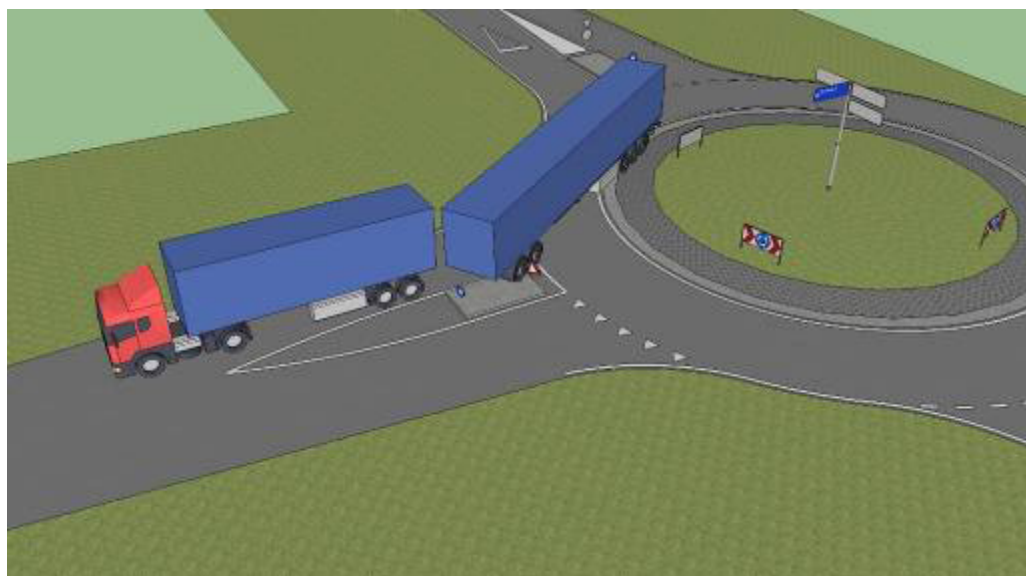
Why did the accident occur?

This accident occurred because the trailer was incorrectly connected, or because the attachment point was damaged while taking the roundabout. It is impossible to establish the exact cause on the basis of the police accident report. It should be noted that the LHV concerned had already travelled a great distance prior to the accident. This means it is highly likely that the sudden defect was the underlying cause of the accident.
